Arboricultural Impact Assessment and Development Impact Report

Site: Stirling Golf Club, 35 Golflinks Road, Stirling

Date: Tuesday, 6 December 2022

ATS6360-035GoIRdDIR R1

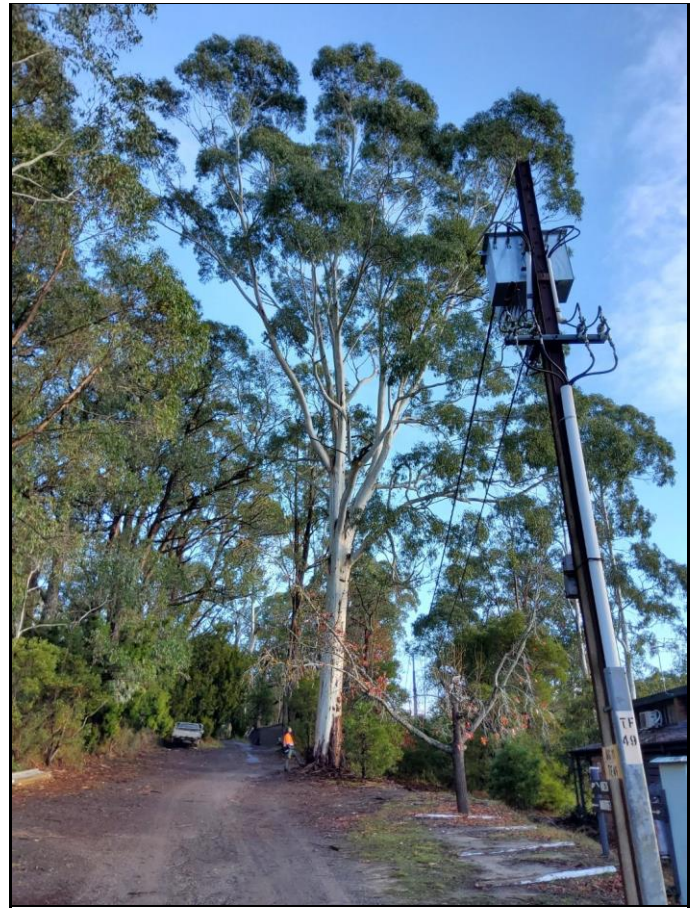
The health and structure of this tree indicate it is in good overall condition and has adapted to its local environment. This tree has a moderate history of small diameter branch failure.

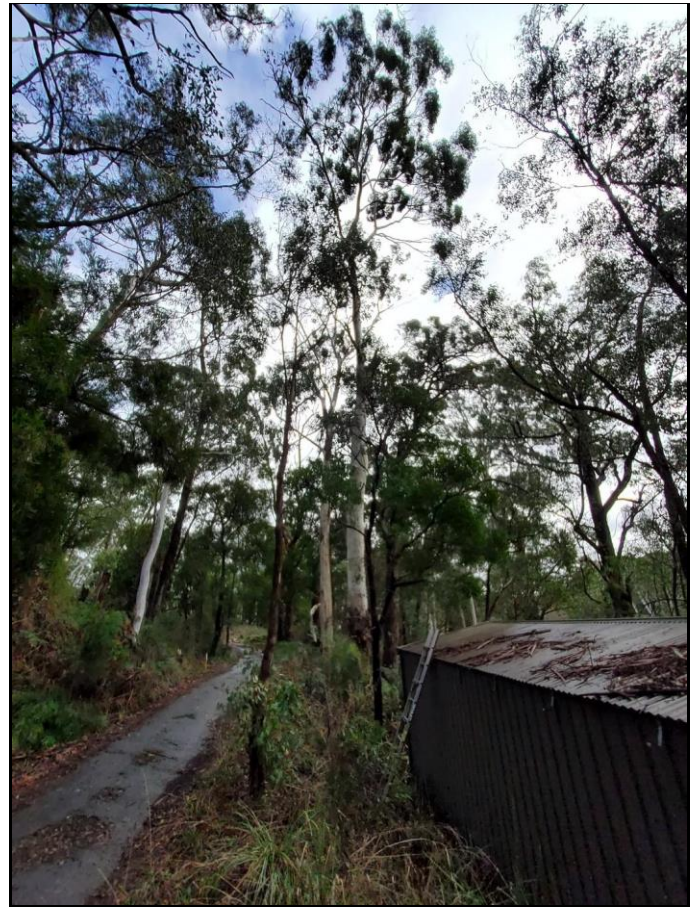
This tree is considered to be in fair overall condition as evidenced by the moderate volume of deadwood and history of branch failure throughout the crown. This tree has a moderate trunk lean however this is natural and not considered to be affecting the overall structural rating.

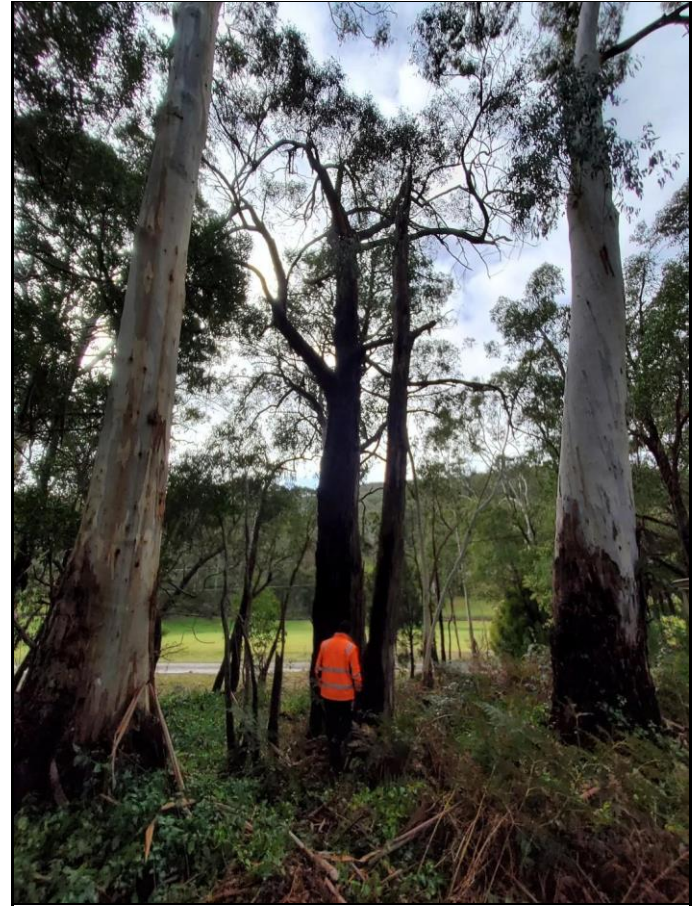
This tree is considered to be in poor overall condition as evidenced by the substantial volume of deadwood throughout the crown and moderate level of branch failure and epicormic growth.

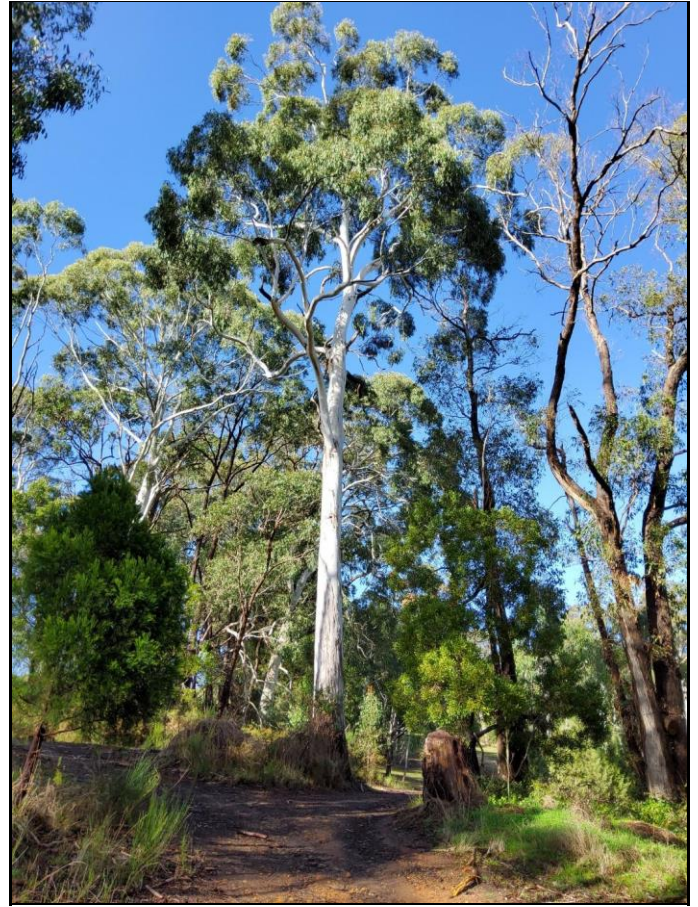
This tree is considered to be in fair condition due to the moderate quantity of deadwood in the crown and slightly reduced overall structural rating.

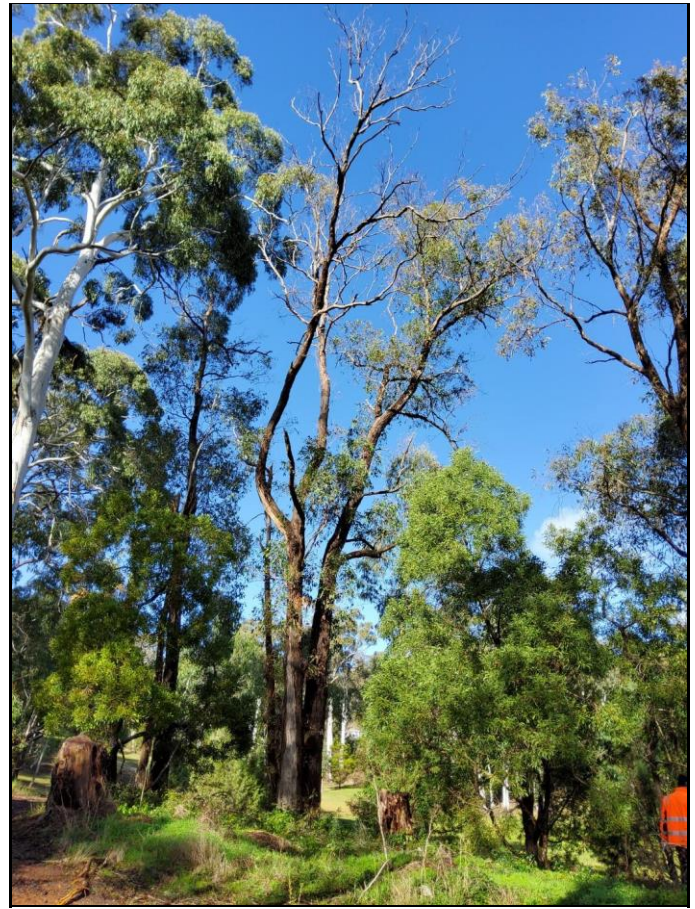
This tree is considered to be in poor overall condition as evidenced by the substantial level of dieback of the upper crown, the presence of poor quality branch unions and the moderate history of branch failure.

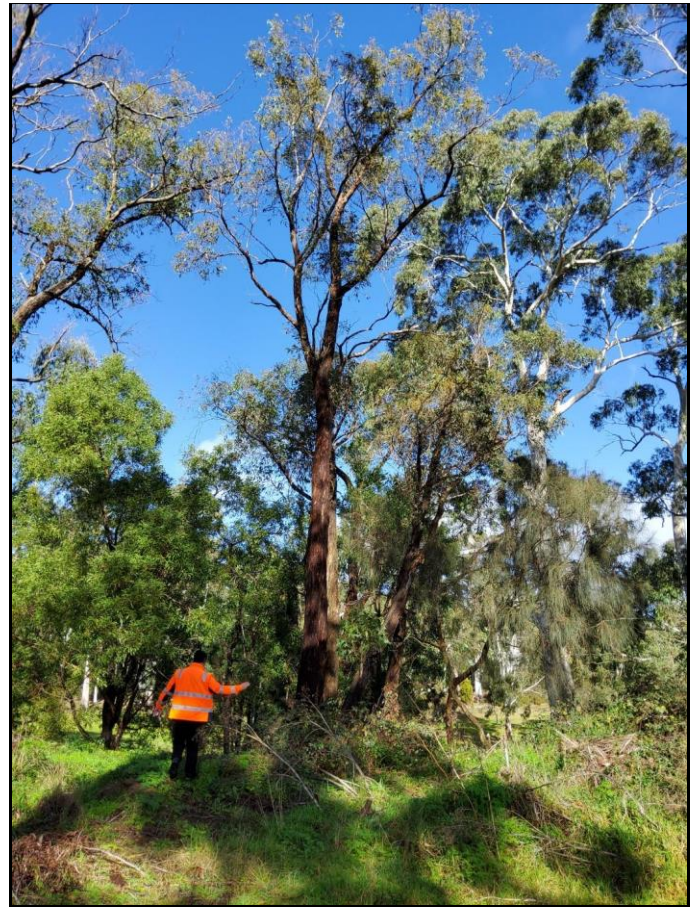
This tree is considered to be in poor overall condition due to the level of dieback in the upper crown.

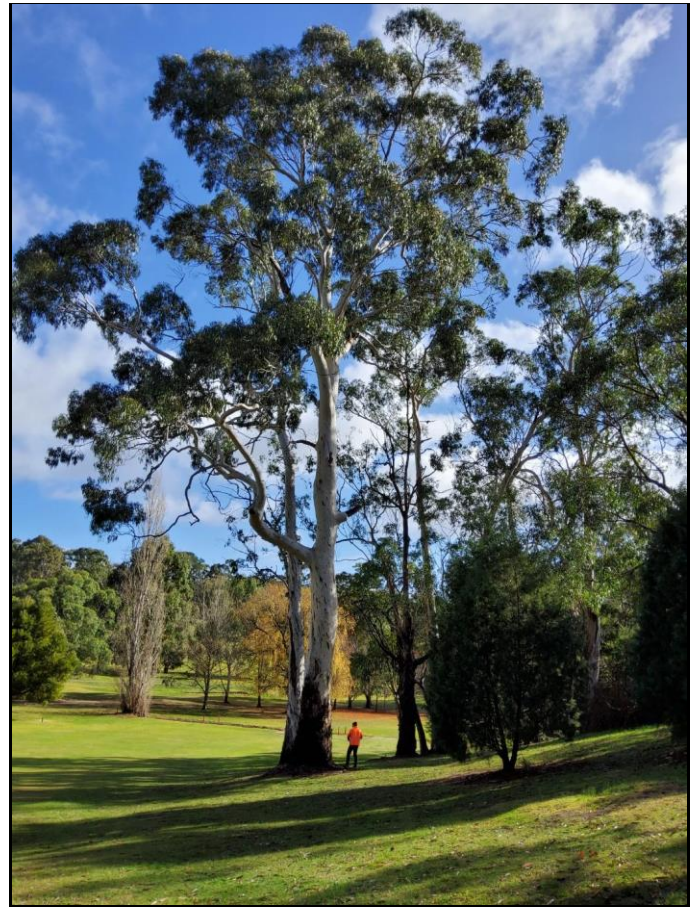
The health and structure of this tree indicate it is in good overall condition and has adapted to its local environment.

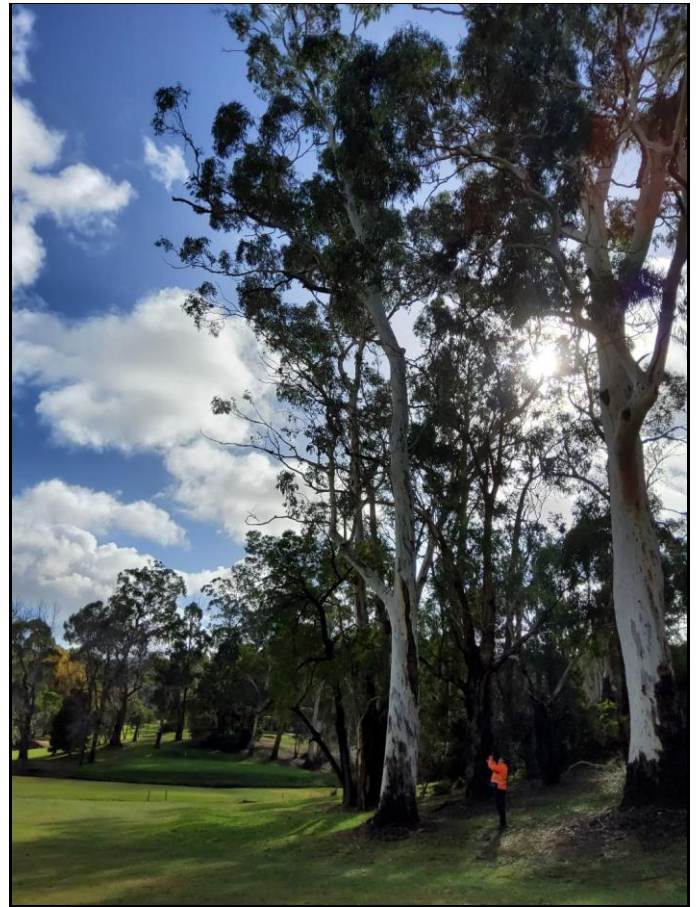
This tree is considered to be in fair overall condition due to the moderate level of deadwood in the crown and the modest level of decay in the trunk and/or branches.

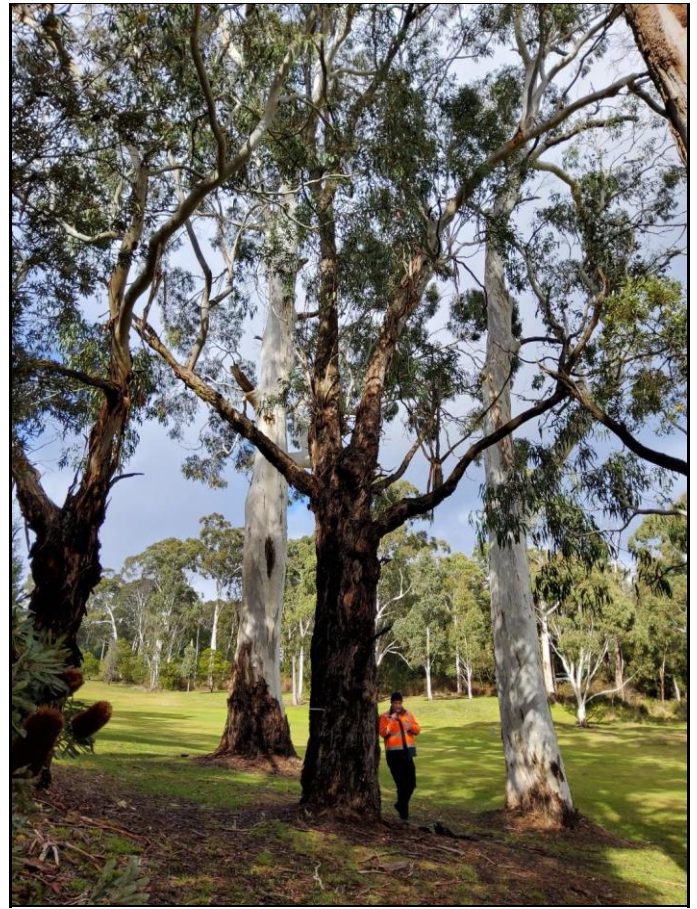
This tree is considered to be in poor overall condition as evidenced by the substantial volume of deadwood and moderate level of epicormic growth throughout the crown.

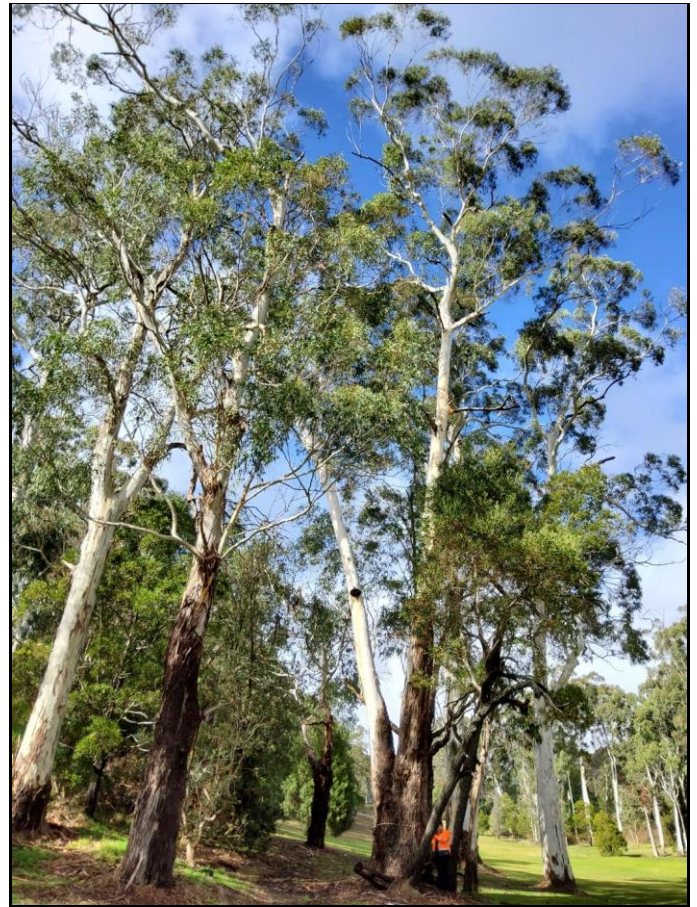
This tree is considered to be in fair overall condition due to its reduced structural rating associated with the moderate level of branch failure and the modest level of decay in the trunk and/or branches. This tree also has a moderate trunk lean that whilst not significant structurally is worthy of noting.

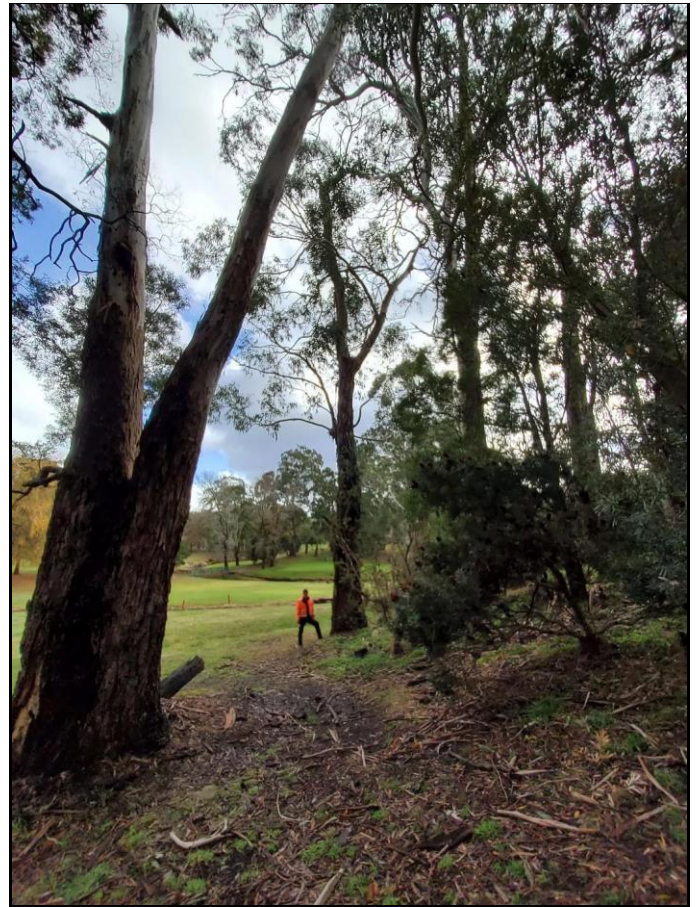
This tree is in poor overall condition as evidenced by the substantial volume of deadwood and dieback and the significantly reduced foliage density. Additionally, this tree has a moderate history of branch failure and an increased level of epicormic growth.

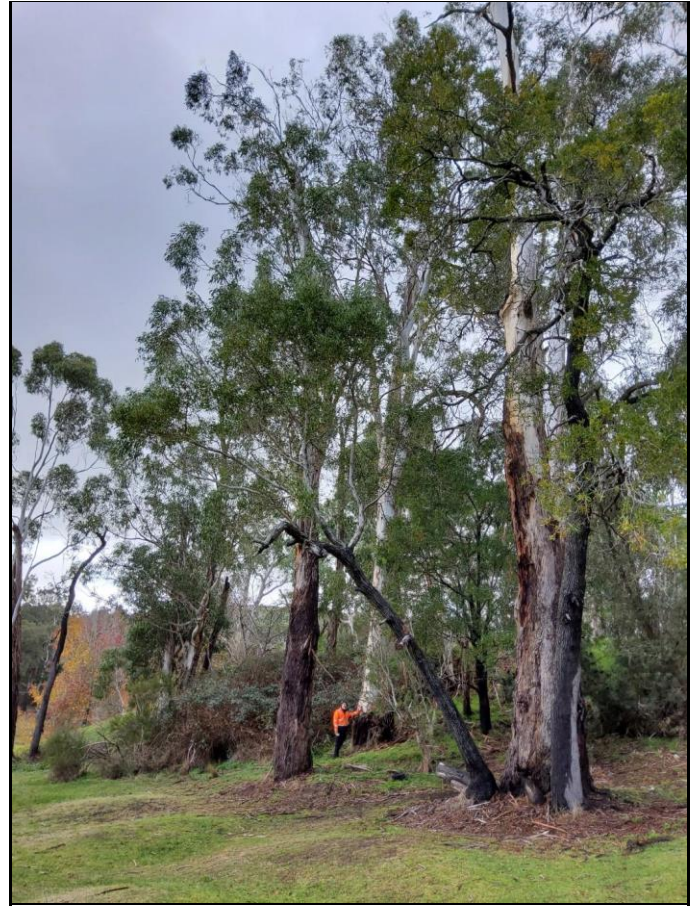
This tree is poor overall condition as evidenced by the high level of deadwood and dieback and the moderate levels of decay and epicormic growth.

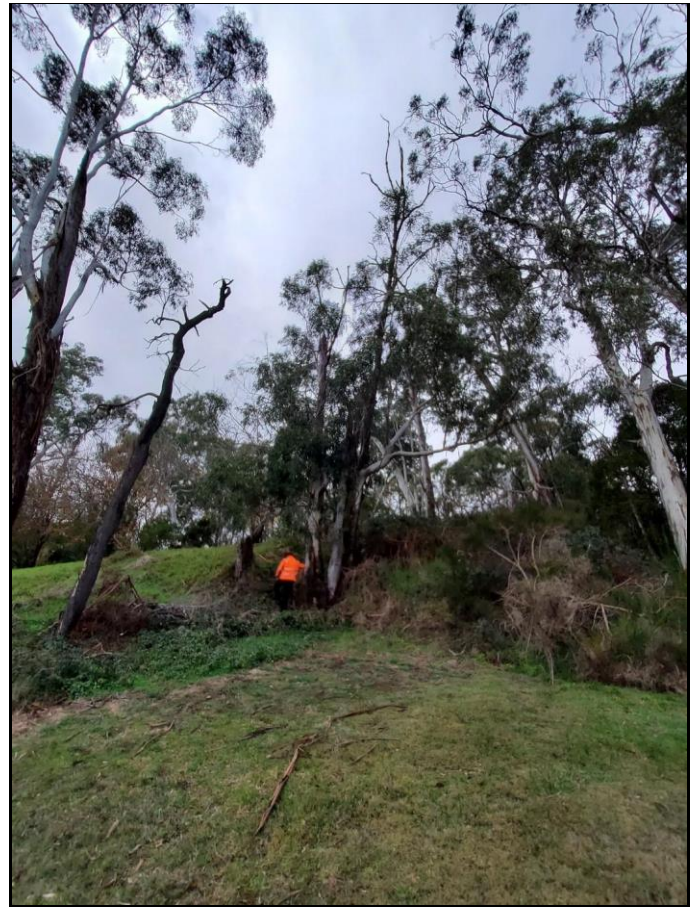
This tree is considered to be in poor overall condition as evidenced by the elevated level of deadwood and dieback throughout the crown and the substantial history of branch failure and associated decay.

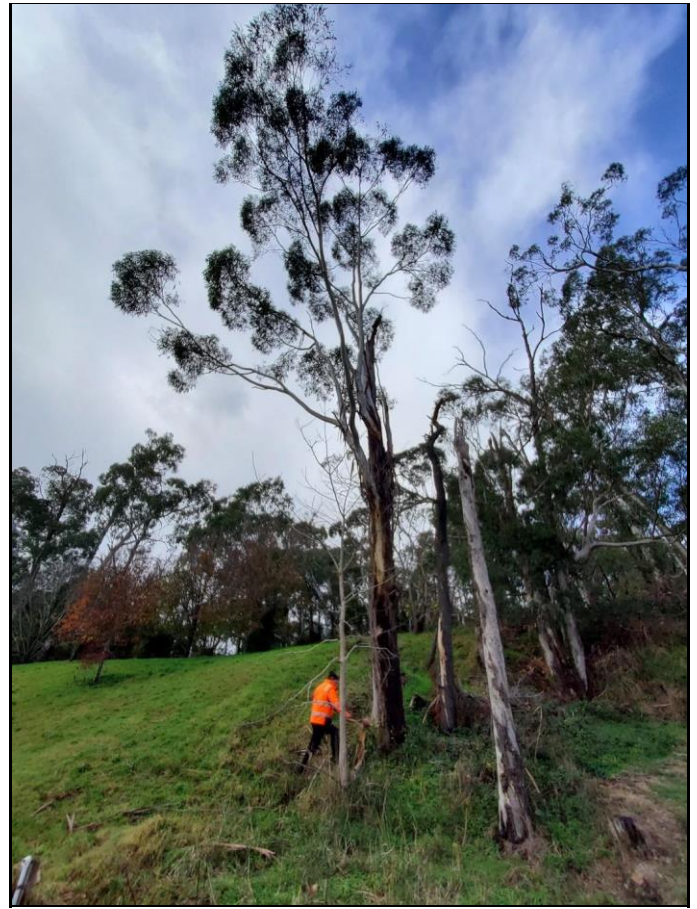
This tree is considered to be in poor overall condition due to the substantial history of branch failure and the moderate volume of deadwood.

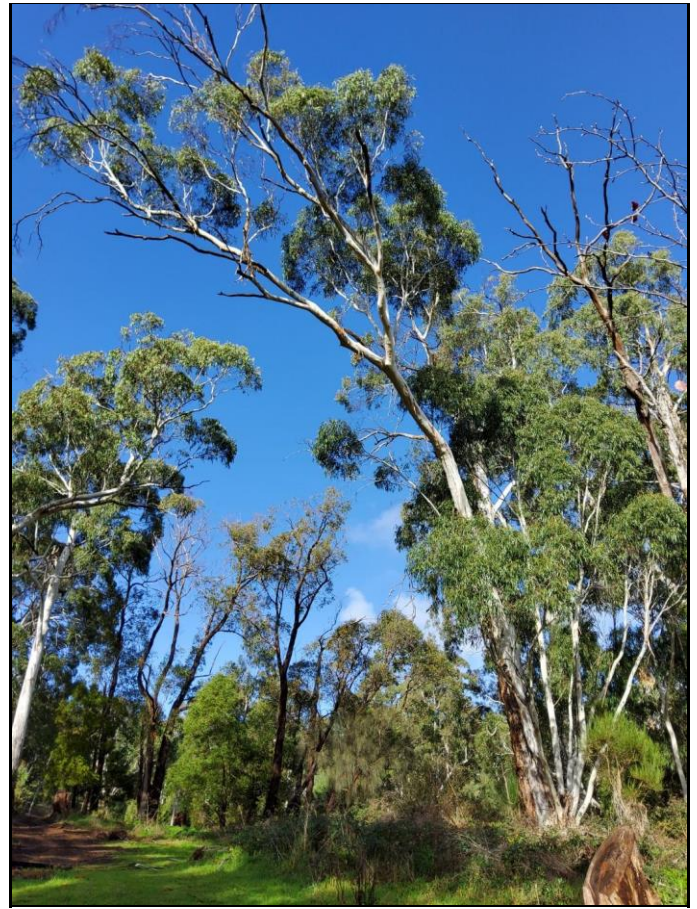
This tree is considered to be in poor overall condition due to the substantial volume of deadwood and the significant level of decay in the trunk. This tree also has a moderate trunk lean that is significant structurally due to the level of decay in the trunk.

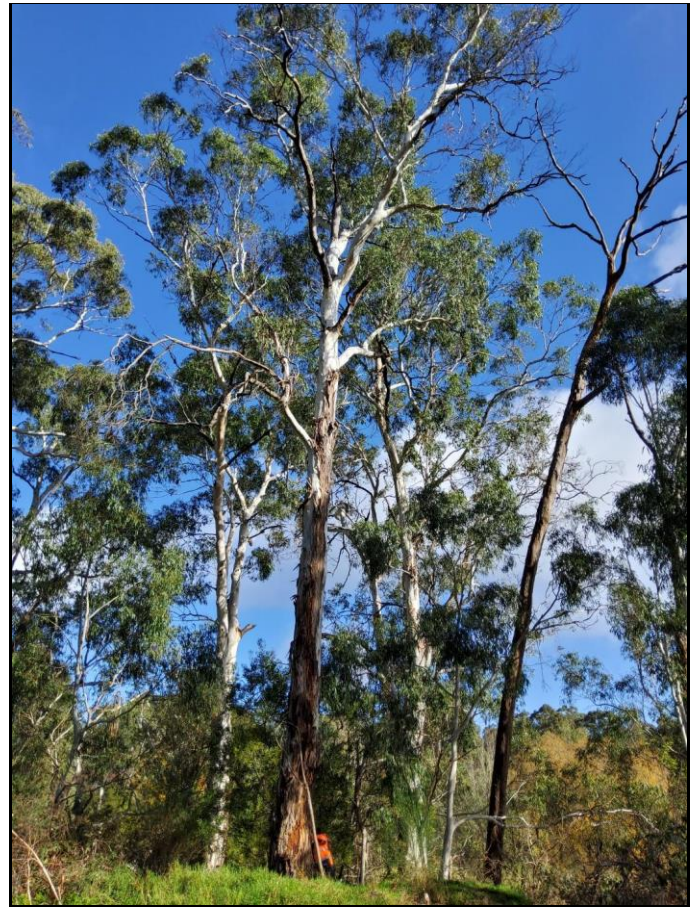
This tree is considered to be in poor overall condition as evidenced by the high level of deadwood and the substantially reduced foliage density throughout the crown. This tree also displays a moderate level of decay, epicormic growth and branch failure.

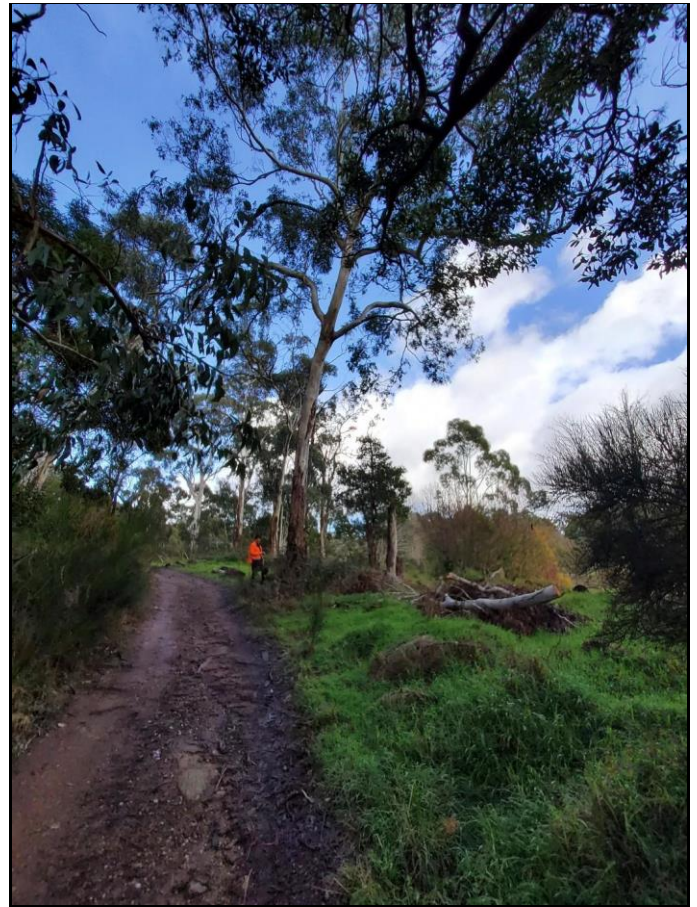
This tree is considered to be in fair overall condition as evidenced by the moderate volume of deadwood and history of branch failure throughout the crown.

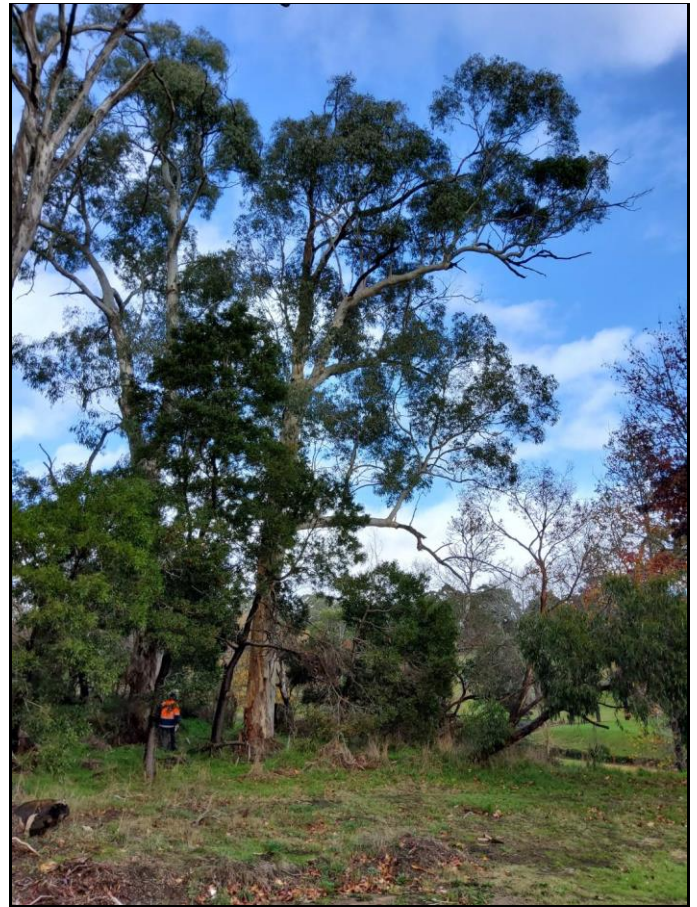
This tree is considered to be in fair overall condition as evidenced by the moderate levels of deadwood and epicormic growth throughout the crown.

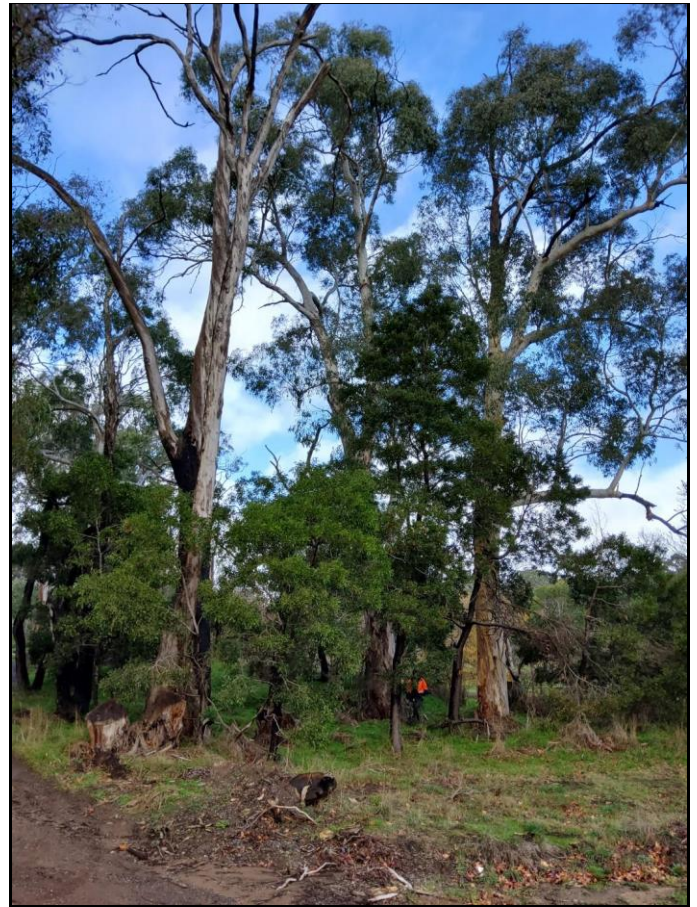
The health and structure of this tree indicate it is in good overall condition and has adapted to its local environment.

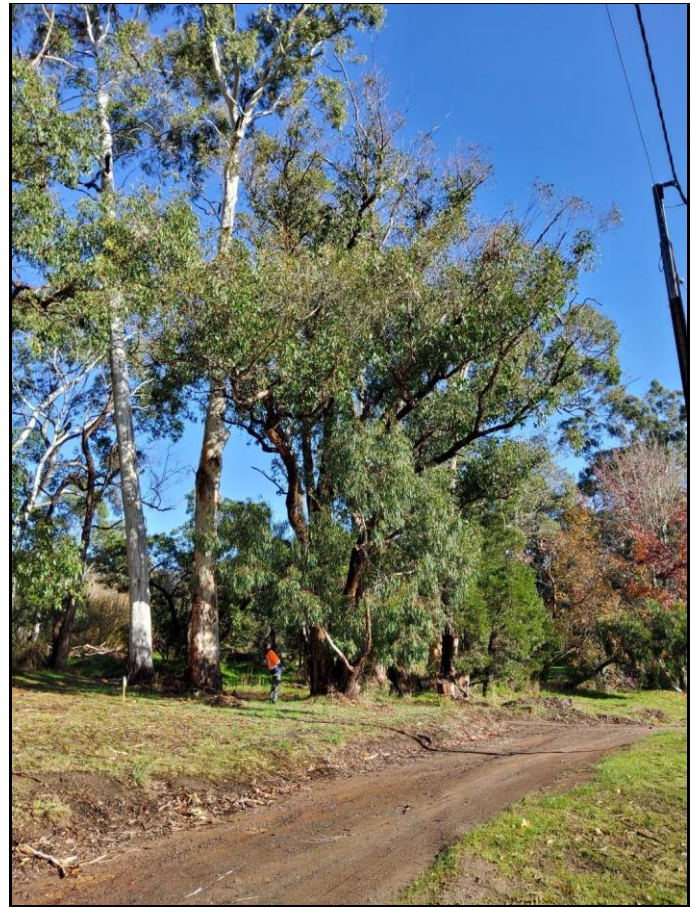
This tree considered to be in poor overall condition as evidenced by the substantial reduction in foliage density, the increased level of dieback and the presence of a partially included union in the primary structure.

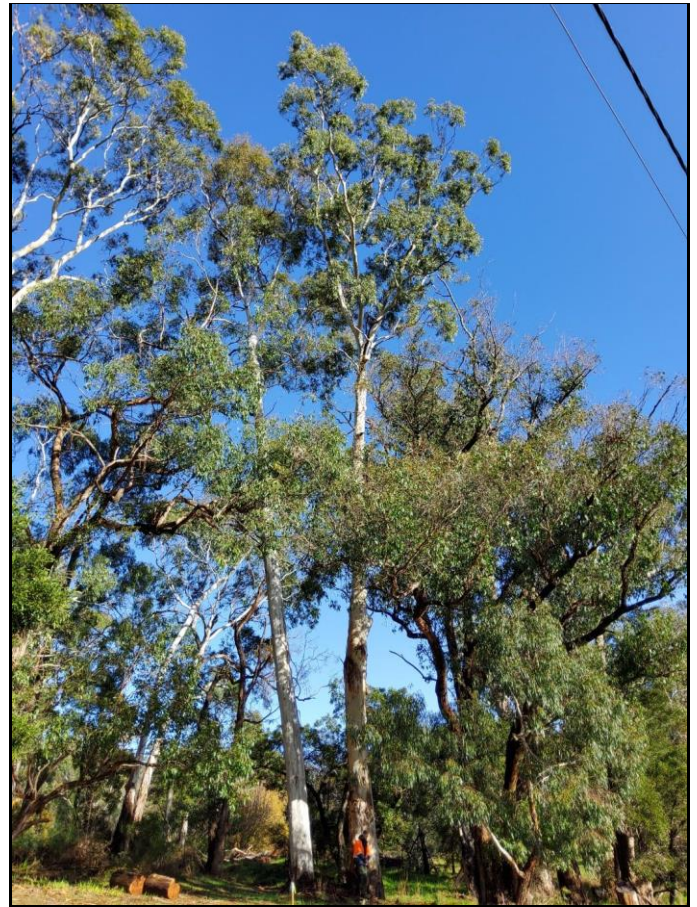
This tree is considered to be in fair condition as indicated by the reduced overall structural rating. This tree also has a moderate trunk lean that whilst not significant structurally is worthy of noting.

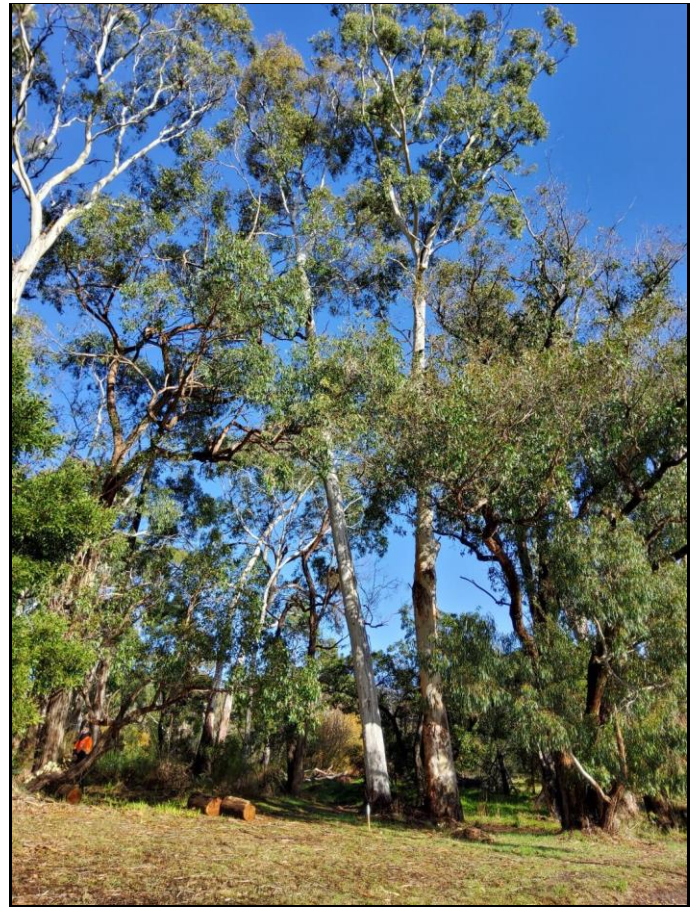
This tree is considered to be in fair overall condition as evidenced by the moderate volume of deadwood and history of branch failure throughout the crown. This tree also has a moderate trunk lean that whilst not significant structurally is worthy of noting.

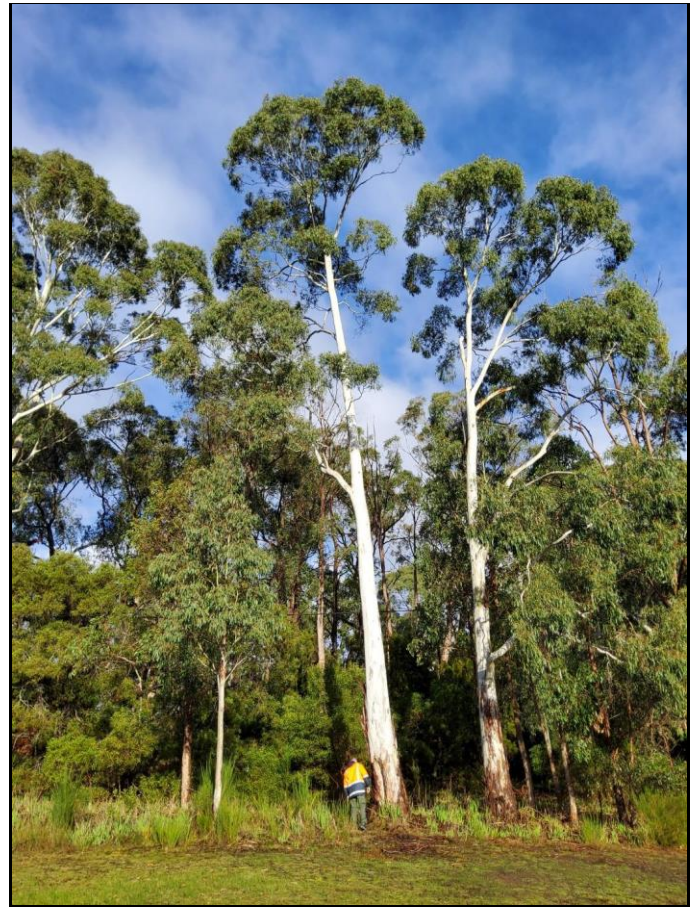
This tree is considered to be in poor overall condition due to its poor structure rating. This tree has a significant history of small diameter branch failure and a moderate level of decay in the trunk.

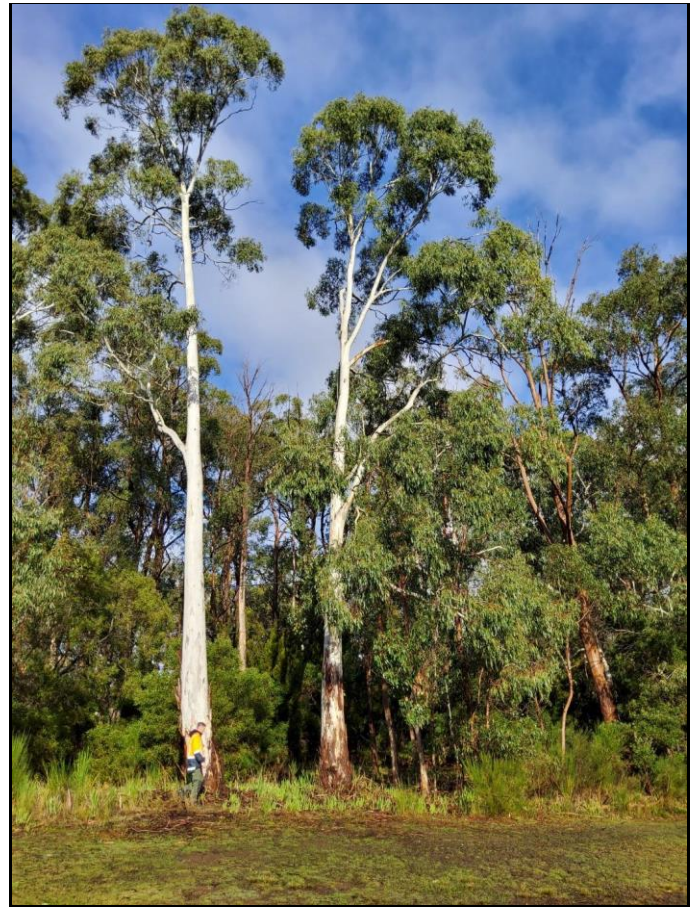
The health and structure of this tree indicate it is in good overall condition and has adapted to its local environment.

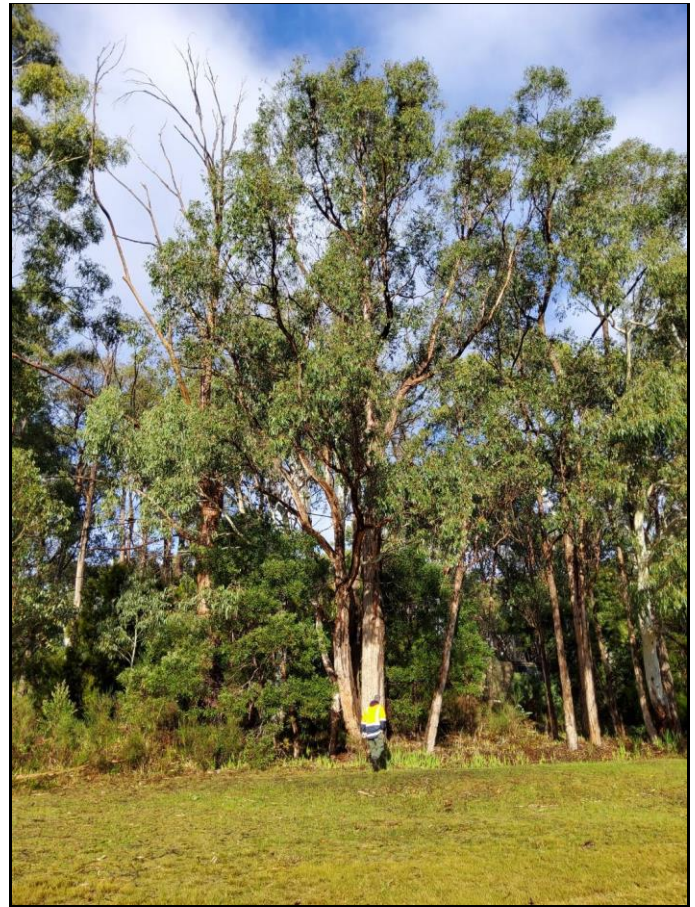
This tree is considered to be in fair condition as indicated by the reduced overall structural rating. This tree has a moderate level of decay in the trunk.

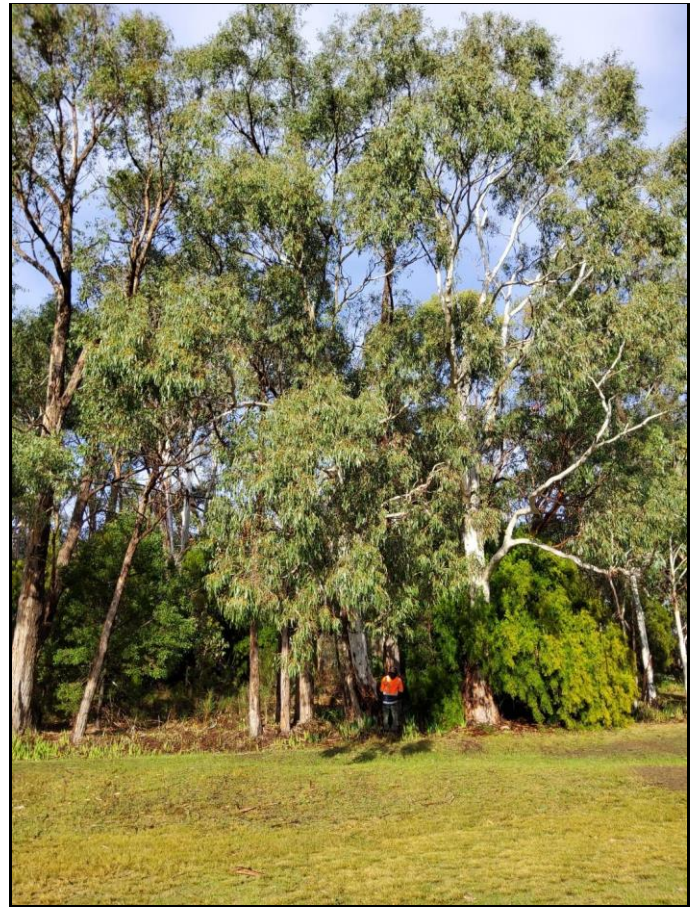
The health and structure of this tree indicate it is in good overall condition and has adapted to its local environment.

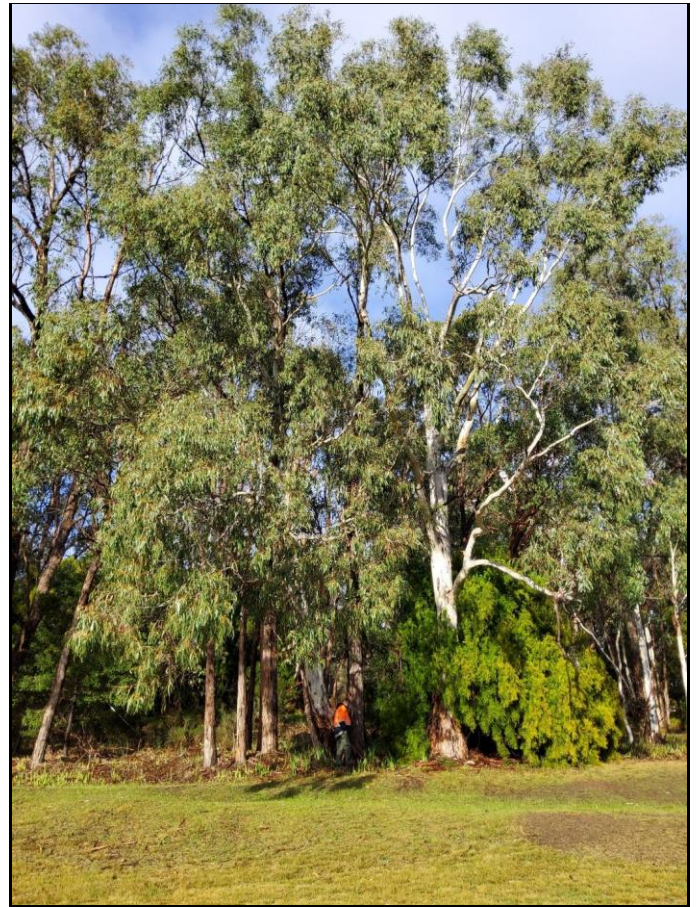
This tree is considered to be in fair overall condition due to its moderately reduced health rating.

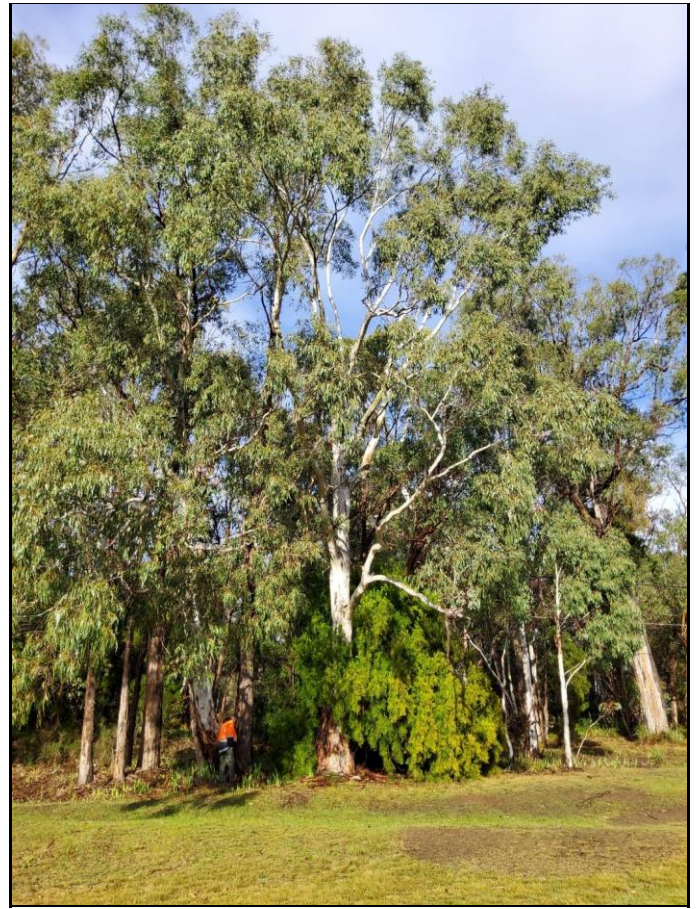
This tree is considered to be in fair overall condition due to its moderately reduced health rating.

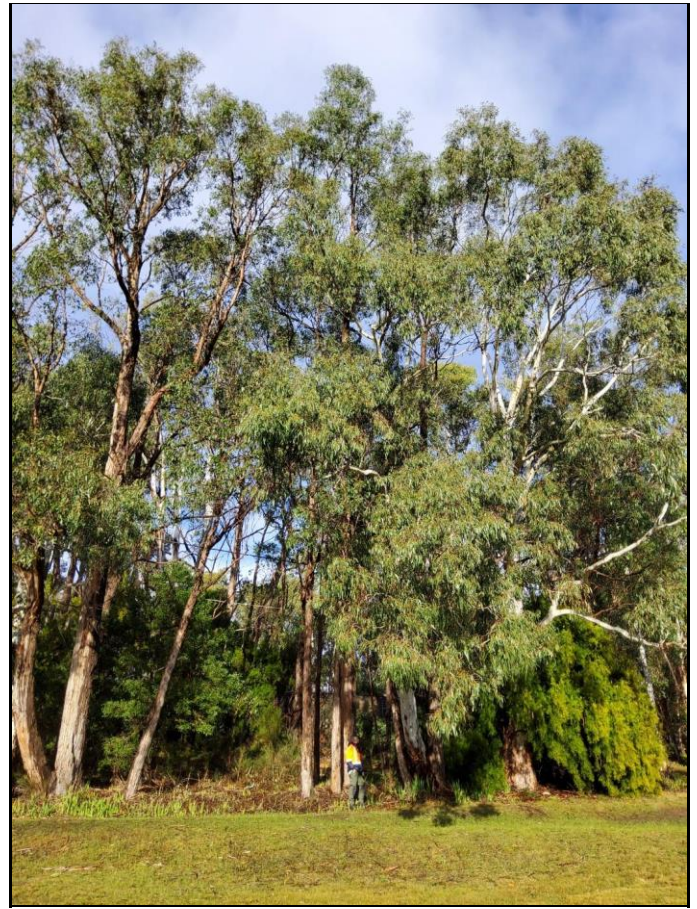
The health and structure of this tree indicate it is in good overall condition and has adapted to its local environment.

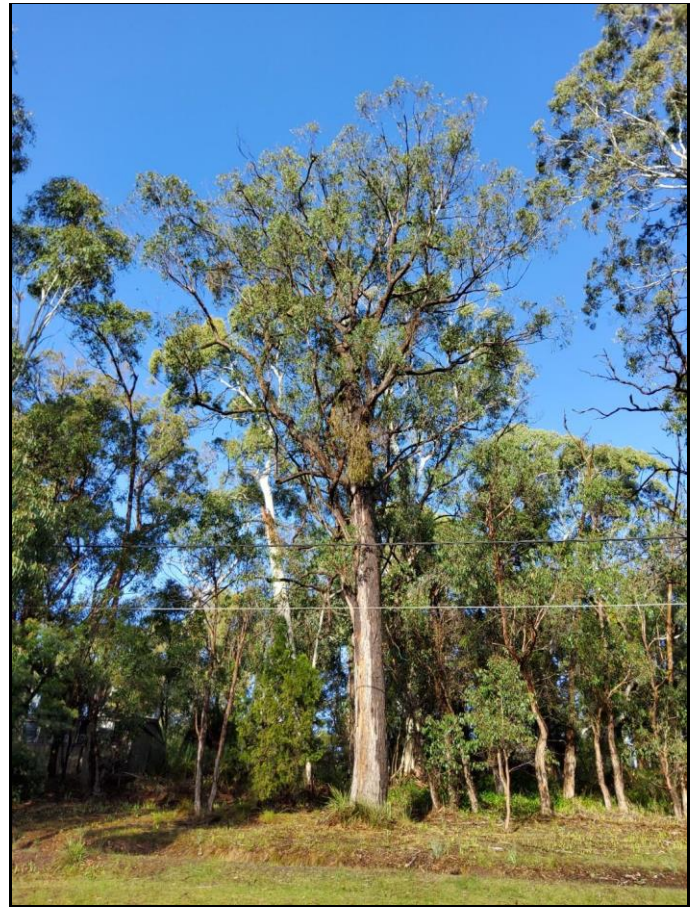
This tree is considered to be in poor overall condition due to a reduced health rating including dieback and deadwood throughout the crown.

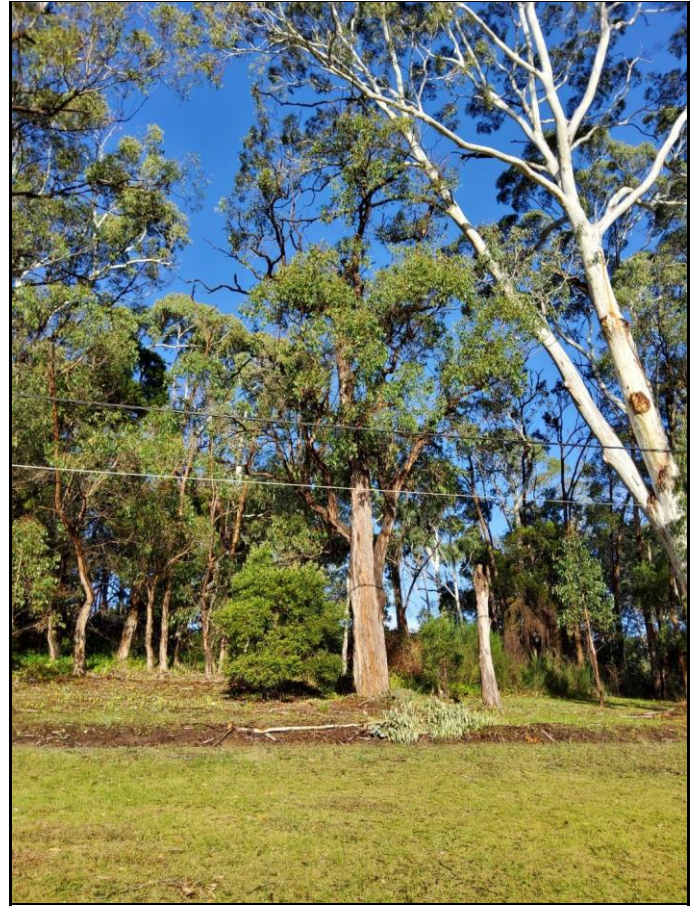
This tree is considered to be in fair overall condition as evidenced by the moderate volume of deadwood and history of branch failure throughout the crown. The crown also retains an above average volume of epicormic growth.

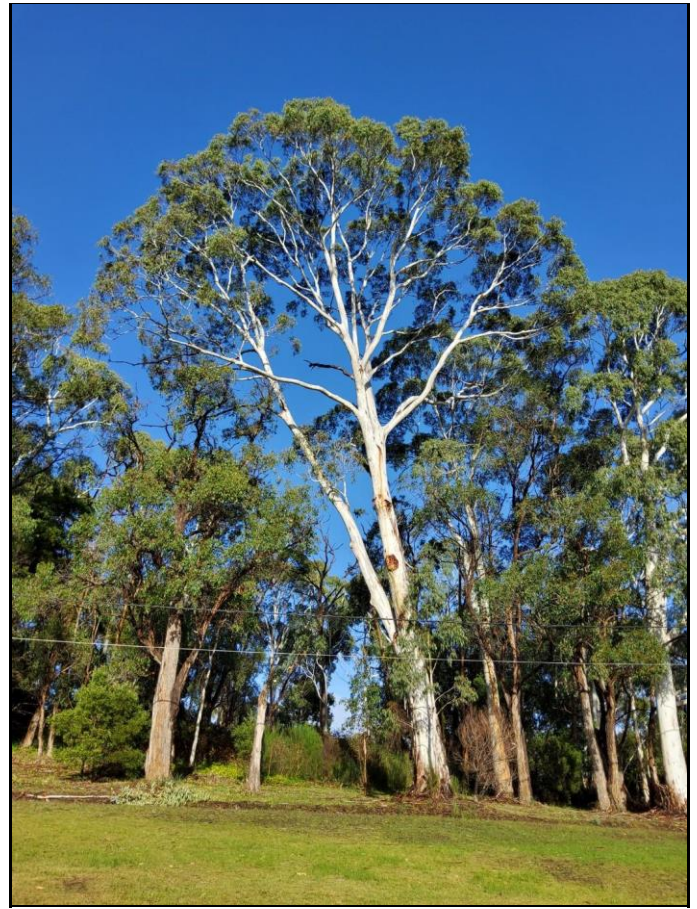
The health and structure of this tree indicate it is in good overall condition and has adapted to its local environment.

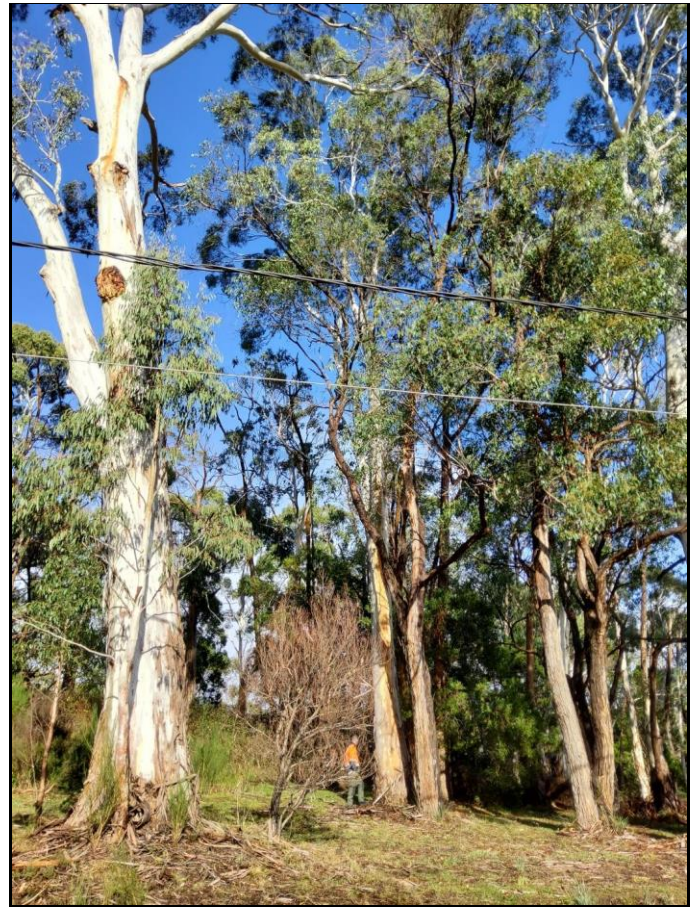
The health and structure of this tree indicate it is in good overall condition and has adapted to its local environment. This tree has a moderate trunk lean however this is natural and not considered to affecting the overall structural rating.

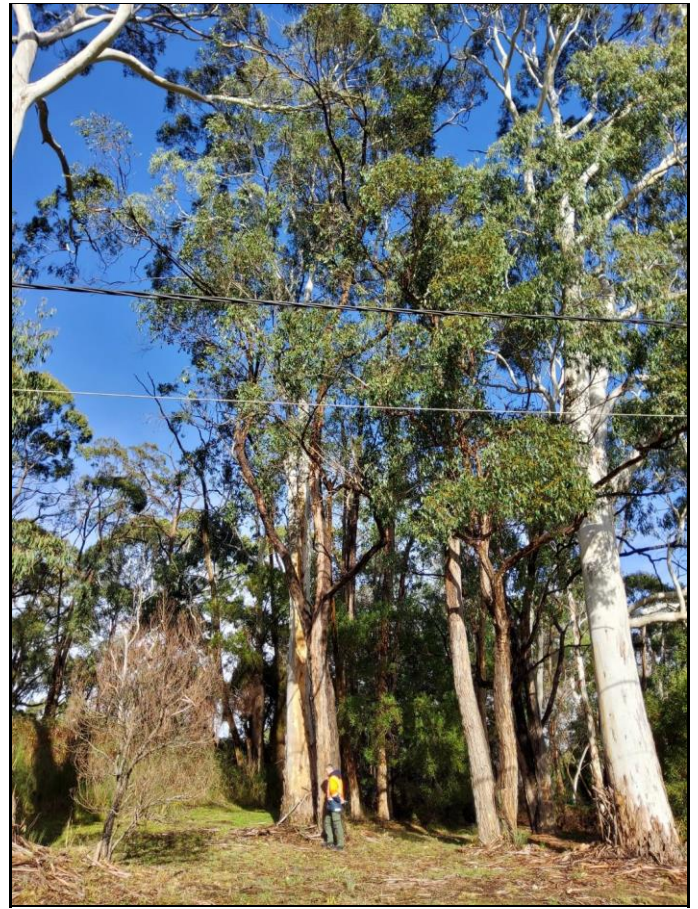
This tree is considered to be in fair condition due to the moderate quantity of deadwood in the crown and slightly reduced overall structural rating. Additionally, this tree has a number of poorly tapered branches throughout the crown.
