Arboricultural Impact Assessment and Development Impact Report

Site: Stirling Golf Club, 35 Golflinks Road, Stirling

Date: Tuesday, 6 December 2022

ATS6360-035GoIRdDIR R1

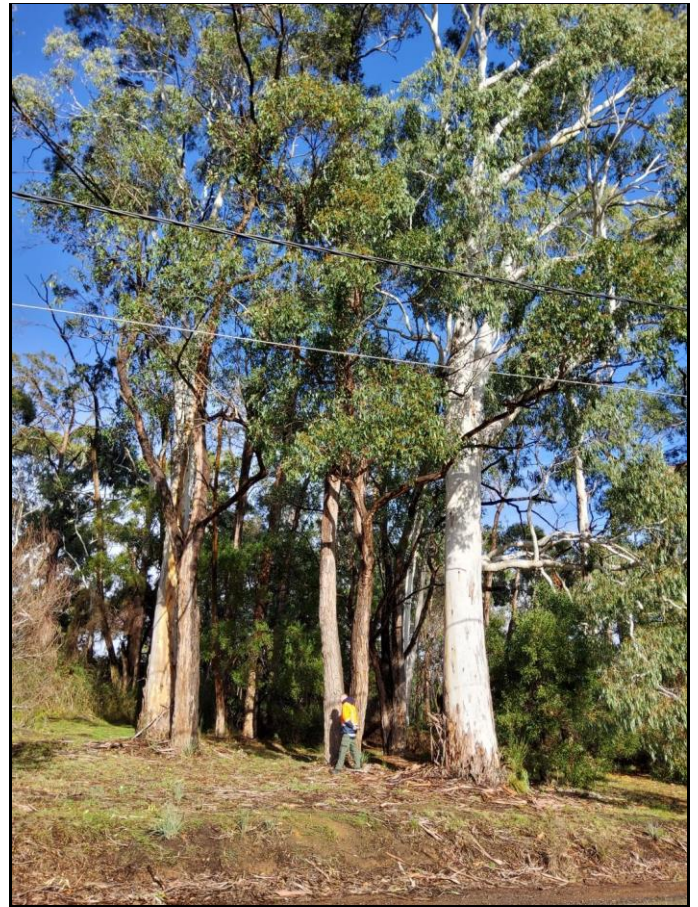
The health and structure of this tree indicate it is in good overall condition and has adapted to its local environment. There is included bark in the primary structure however this is not impacting the overall structural rating at this point.

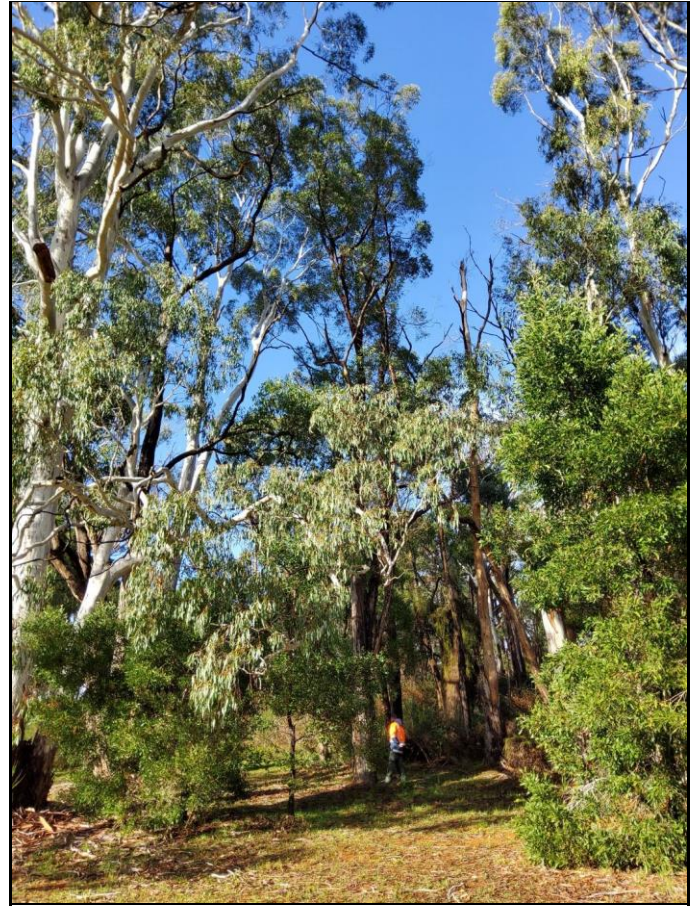
This tree is considered to be in poor overall condition due to the structure of the primary trunk union which is supporting a dead leader.

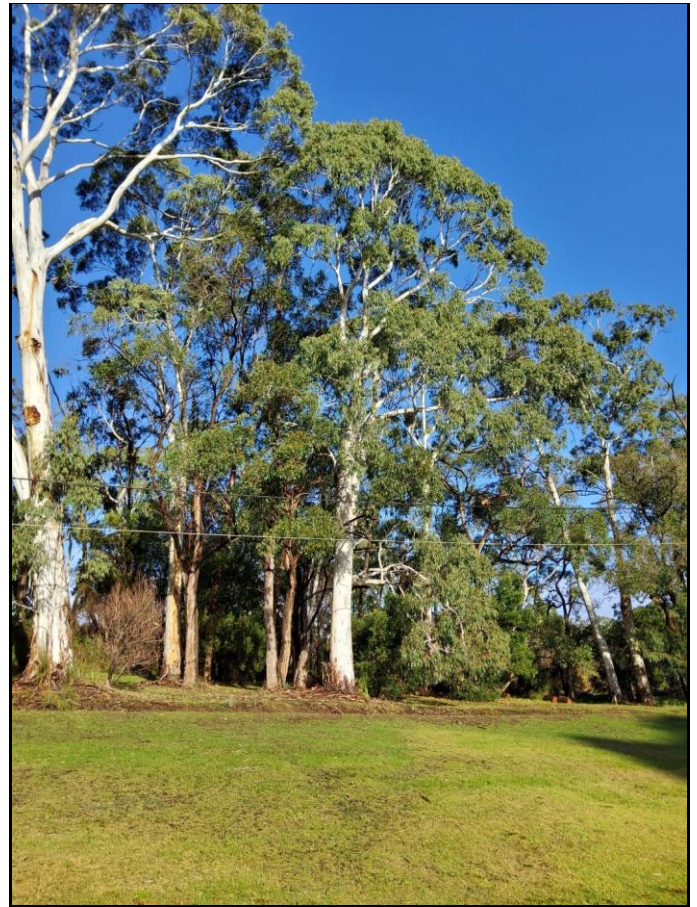
This tree is considered to be in fair overall condition due to it having a moderate history of branch failure impacting its structural rating and therefore its overall condition.

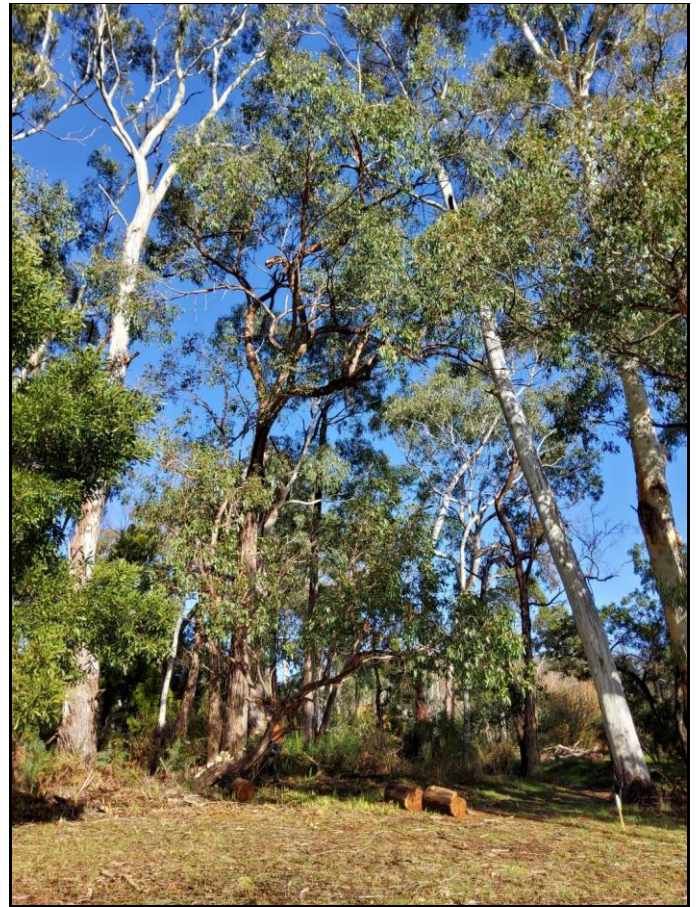
This tree is considered to be in fair overall condition due to it having a moderate history of branch failure impacting its structural rating and therefore its overall condition.
