# Preliminary Geotechnical Investigation Report

## Civil Engineering at Stirling Golf Club

<b>Job Number</b>	275203
<b>Client</b>	Venture Capital Developments Pty Ltd
<b>Site</b>	Stirling Golf Club, 35 Golflinks Road, STIRLING, SA 5152
<b>Date</b>	04/05/2021
<b>Revision</b>	0

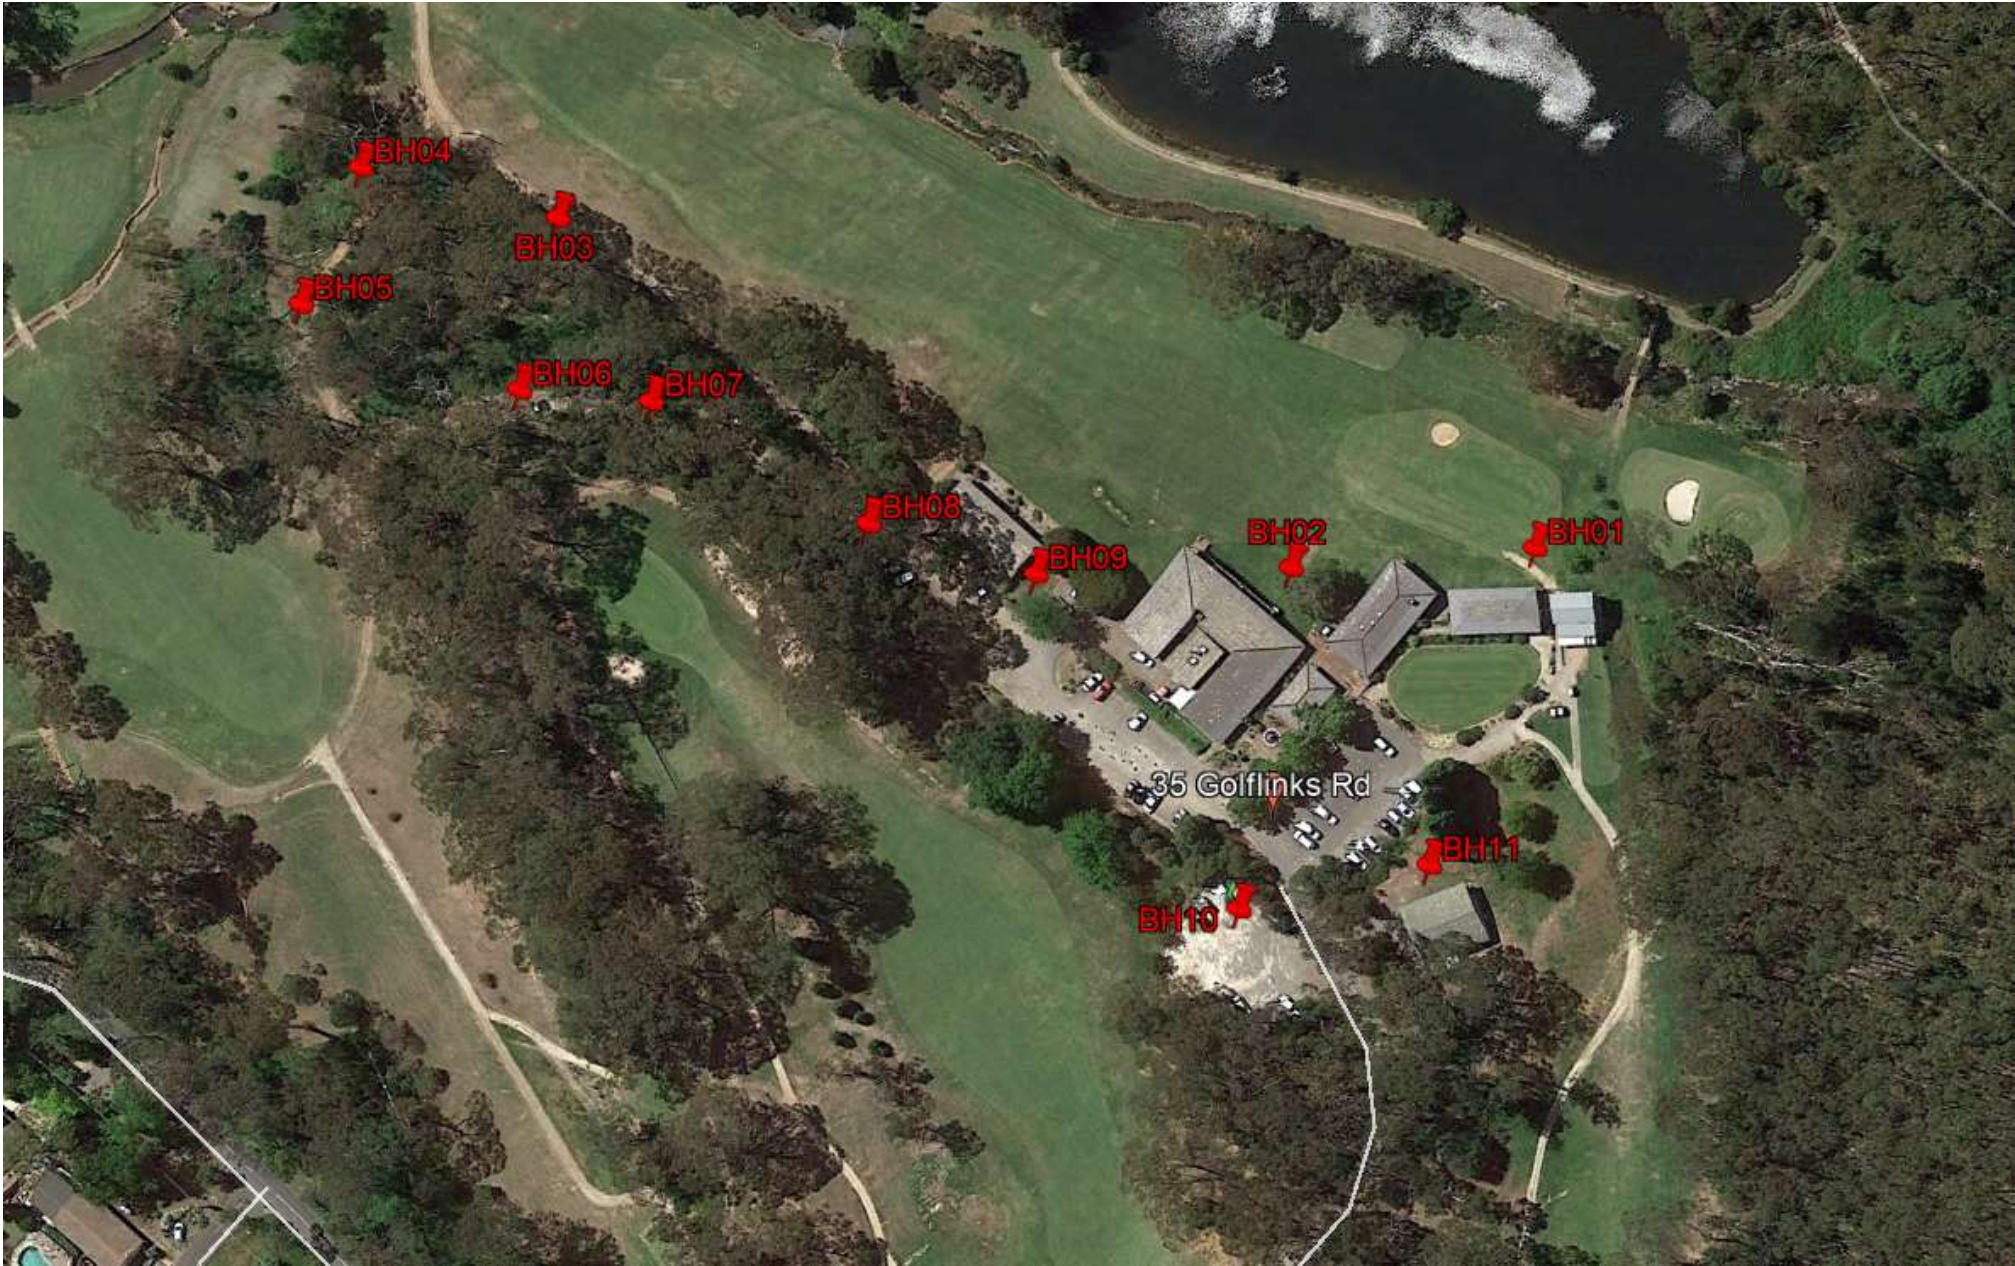
Site plan

Borehole were located according to verbal advice provided by yourselves, and are shown on the site plan included in Appendix A. As advised, an additional borehole than proposed in our initial proposal was added. A total of 11 Boreholes were drilled using a Rockmaster 4WD mounted drill rig owned and operated by SPK Geodrill under the supervision of a Geotechnical Engineering on 29<sup>th</sup> April 2021.
