Arboricultural Impact Assessment and Development Impact Report

Site: Stirling Golf Club, 35 Golflinks Road, Stirling

Date: Tuesday, 6 December 2022

ATS6360-035GoIRdDIR R1

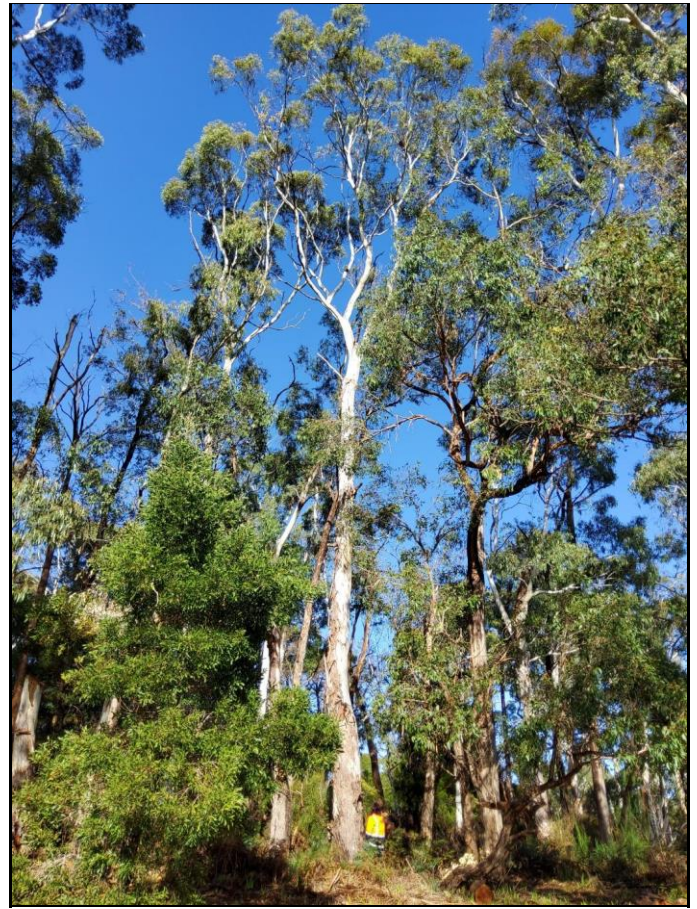
The health and structure of this tree indicate it is in good overall condition and has adapted to its local environment.

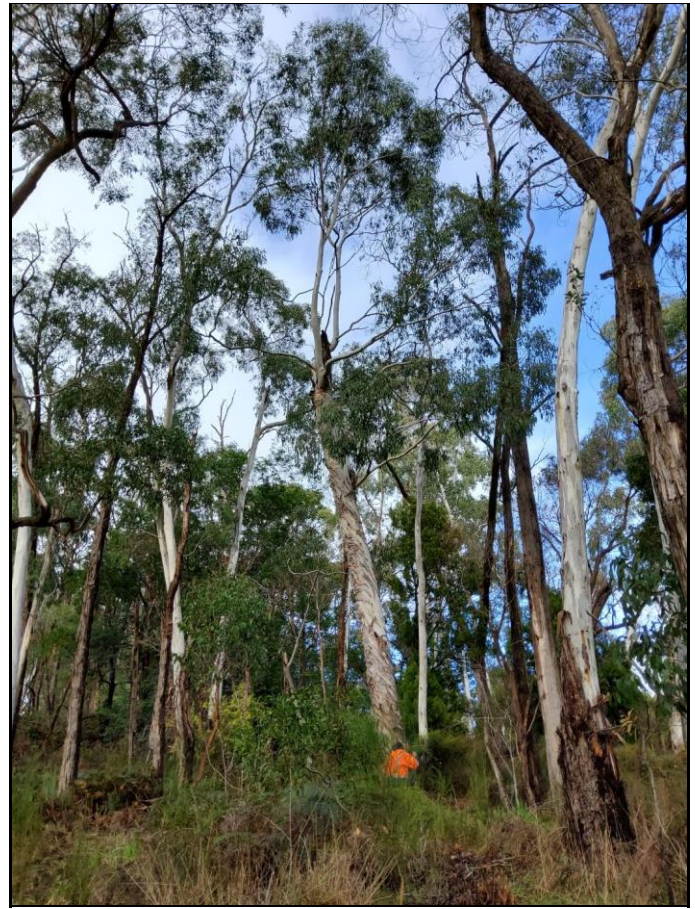
This tree is considered to be in poor overall condition due to a history of substantial failure, a moderate level of epicormic growth and an overall reduction in its health rating. The trunk of this tree has failed at approximately eight metres above ground level, with the crown now consisting of epicormic regrowth.

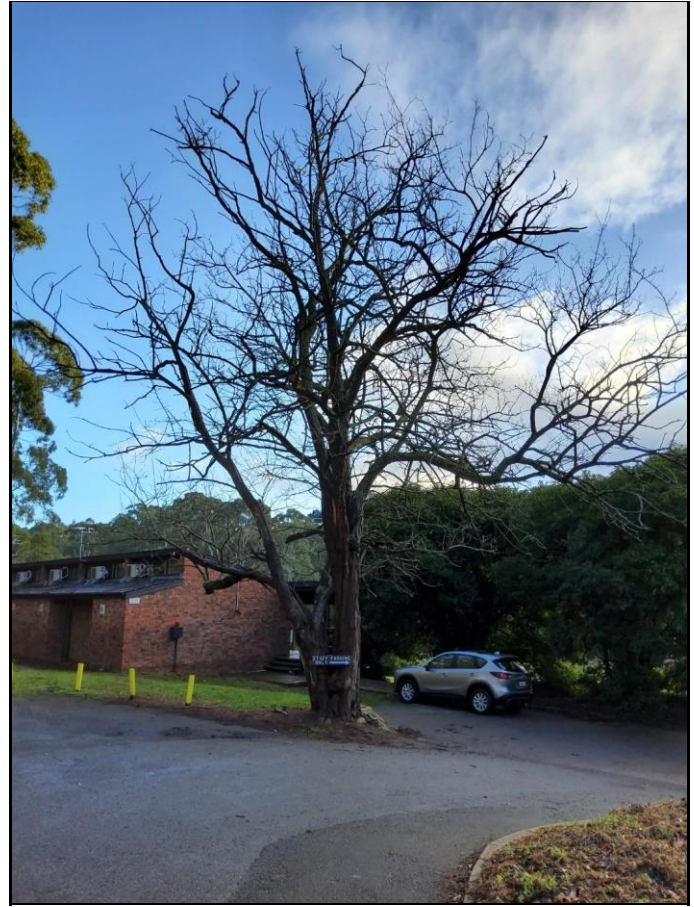
This tree is considered to be in poor overall condition due to its poor health and reduced structure rating. This tree has a codominant form with included bark in the primary structure, there is also a moderate level of decay in the trunk and a substantial volume of deadwood in the crown.

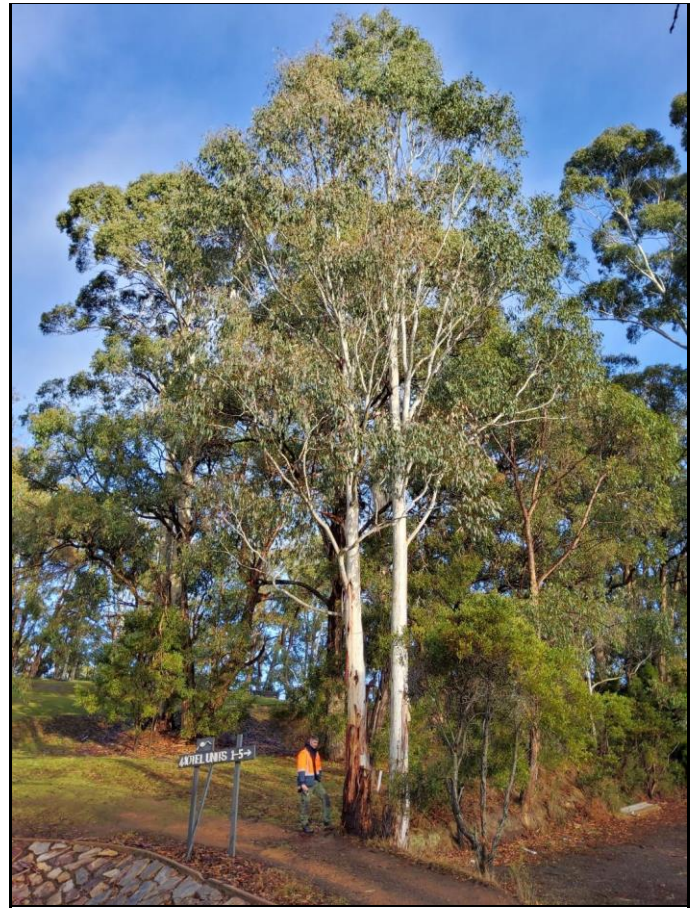
This tree is considered to be in fair condition as indicated by the reduced overall structural rating. This tree has a moderate history of small diameter branch failure.

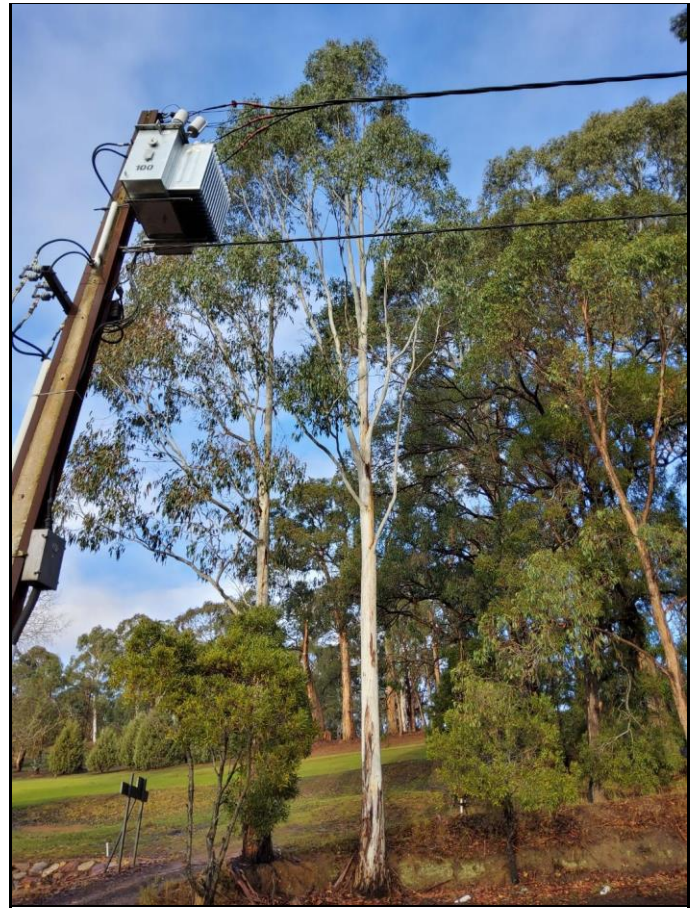
The health and structure of this tree indicate it is in good overall condition and has adapted to its local environment.

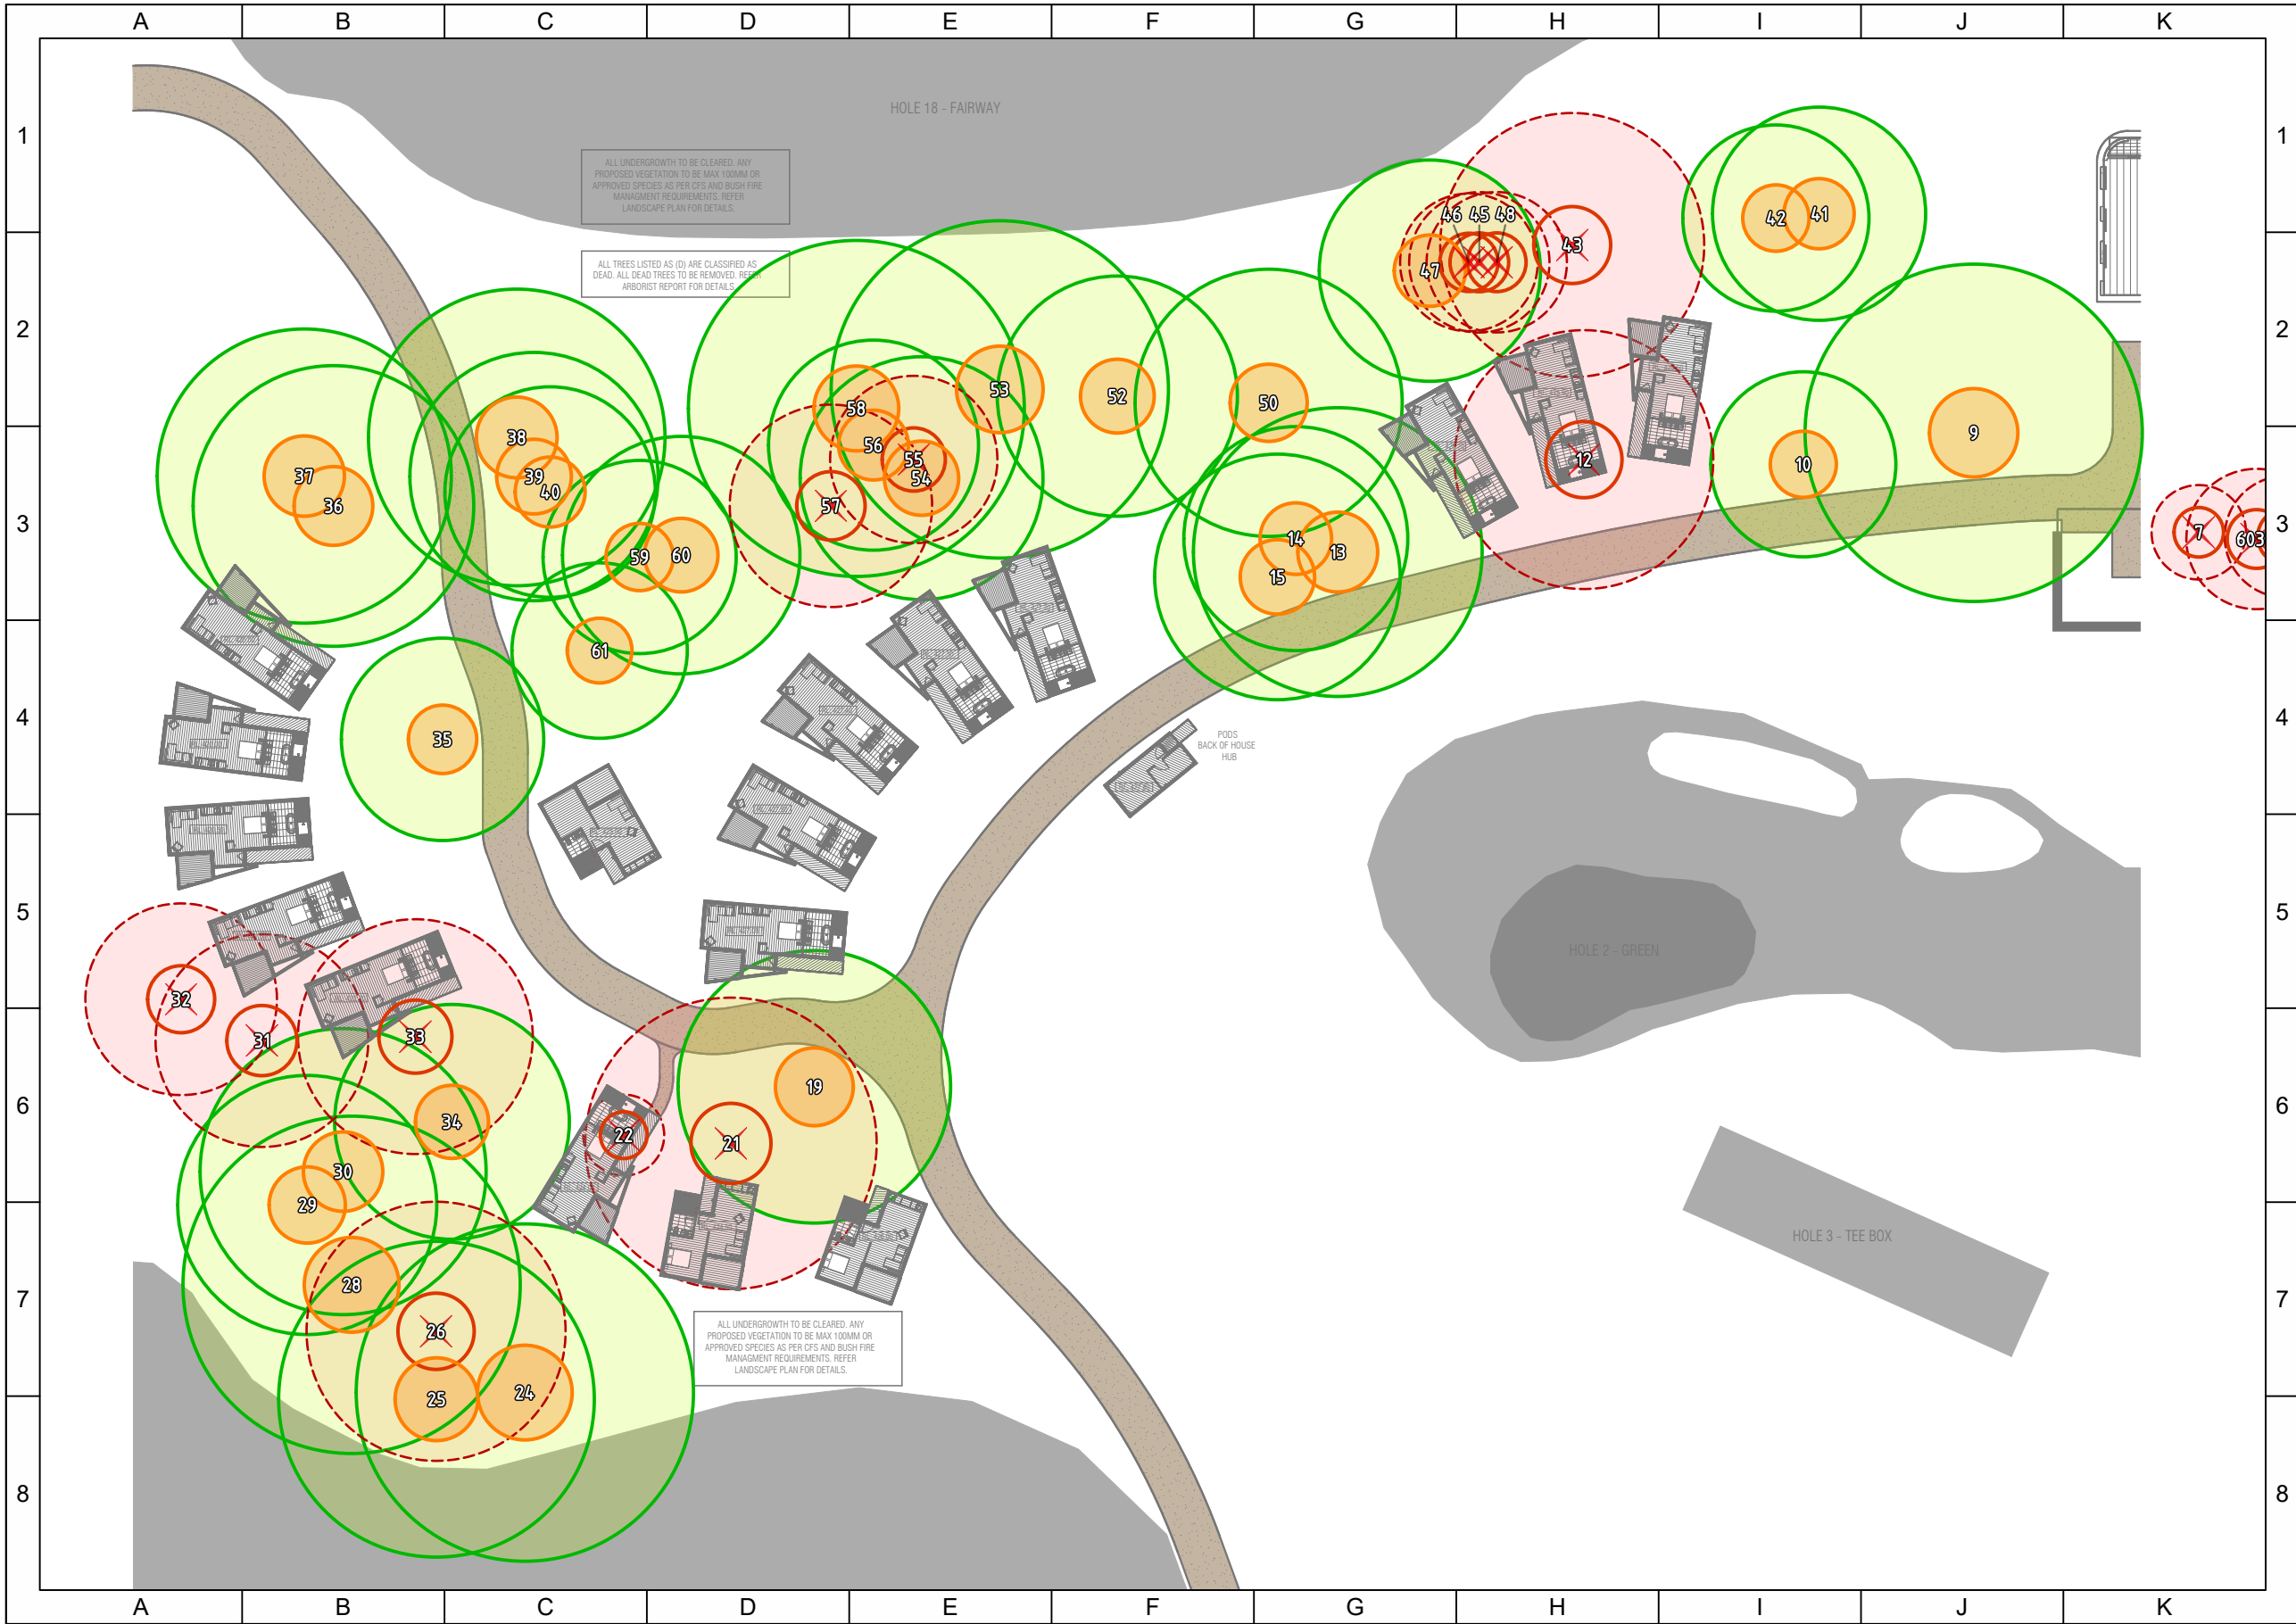
Tree Removals

The encroachment for Trees 12, 21, 22 and 33 is greater than 20% and will cause tree damaging activity that will result in the decline, death or failure of these trees. The encroachment impacts the SRZ and/or the trunk and as such they will be destabilised by the proposed work and they are therefore considered to be Conflicted by the proposed development. Additionally, there are thirteen trees that have been identified for removal as part of the bushfire mitigation requirements for this project, these trees are also considered to Conflicted by the proposed development.
